DEPARTMENT OF TRANSPORTATION

Contract #: 04-0120F4Cty: SF/ALA Rte: 80 PM: 13.2/13.9File #: 1.28**WELDING INSPECTION REPORT****Resident Engineer:** Pursell, Gary**Address:** 333 Burma Road**City:** Oakland, CA 94607**Report No:** WIR-014033**Date Inspected:** 14-May-2010**Project Name:** SAS Superstructure**OSM Arrival Time:** 630**Prime Contractor:** American Bridge/Fluor Enterprises, a JV**OSM Departure Time:** 1500**Contractor:** American Bridge/Fluor Enterprises, a JV**Location:** Job Site

Summary of Items Observed:

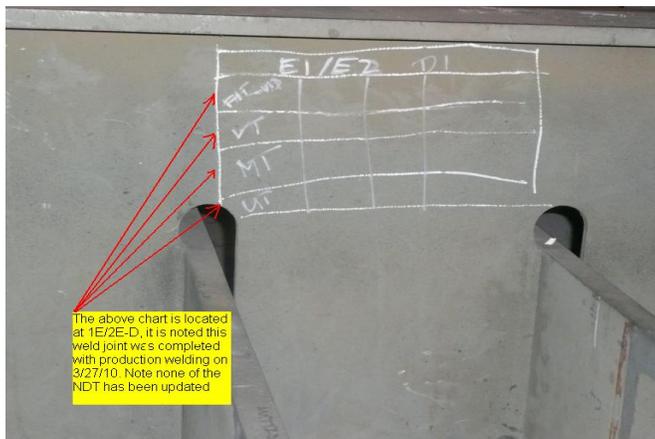
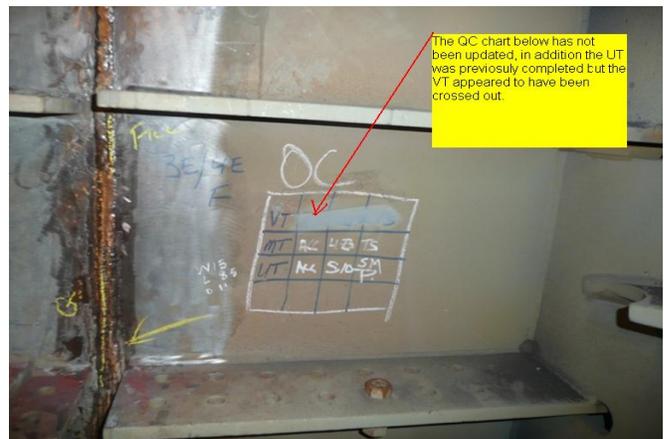
The QA Inspector Rick Bettencourt and the QA Inspector Mike Foerder randomly observed all of the QC NDT status charts in an attempt to determine the status of several weld joints with outstanding weld repairs. After the review of the charts was completed it was noted by both inspectors the charts were not all updated thus it was not possible to accurately determine the status of the NDT performed by the SE QC Inspectors. Pictured below is an example of an NDT chart that does not appear to be completed.
