**DEPARTMENT OF TRANSPORTATION**

Contract #: 04-0120F4Cty: SF/ALA Rte: 80 PM: 13.2/13.9File #: 13.28**WELDING INSPECTION REPORT****Resident Engineer:** Pursell, Gary**Address:** 333 Burma Road**City:** Oakland, CA 94607**Report No:** WIR-014071**Date Inspected:** 18-May-2010**Project Name:** SAS Superstructure**OSM Arrival Time:** 1000**Prime Contractor:** American Bridge/Fluor Enterprises, a JV**OSM Departure Time:** 1830**Contractor:** Oregon Iron Works Clackamas, Or.**Location:** Clackamas, OR

**Hinge-K Pipe Beam Assembly 101A-4:**

**Hinge-K Pipe Beam Assembly 102A-3:**

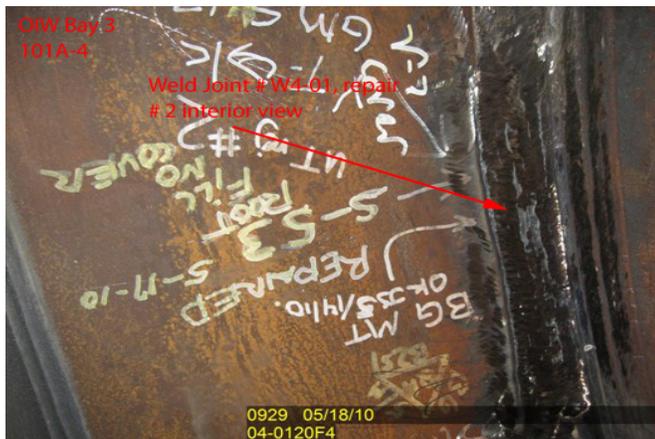
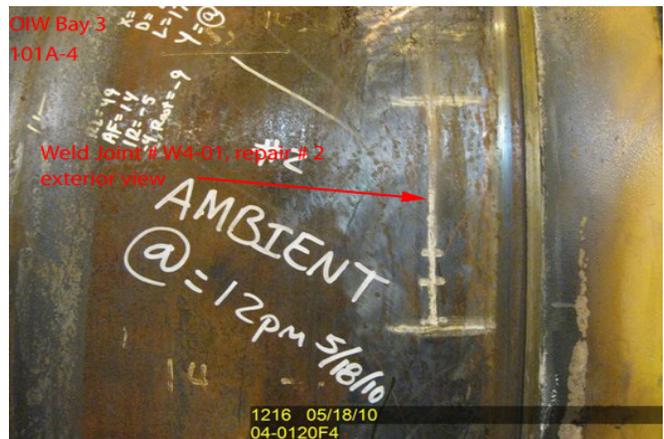
The QA Inspector observed that the Flux-Core arc welding (FCAW) on the two non-critical weld repairs were completed on the previous swing shift. The QA Inspector noted that this was the Complete Joint Penetration AWS D1.5 B-U7-S, Fuse 120A-4 to Forging 102A- designated as Weld Joint # W4-01. The QA Inspector observed that Lead QC Inspector Mike Gregson was present and QC Inspector Gregson explained that incorrect filler metal was utilized, on one of the repairs. See Summary of Conversations and attached pictures below..

Lead QC Inspector Gregson informed the QA Inspector that WID # V7 (Vinny Vue) had continued the Flux Core Arc Welding, where the previous day shift had left off, on the interior weld repair. The QA Inspector noted that per the completed OIW Ultrasonic Testing Report (# 2244-10-UT-04), this non-critical repair was plotted and

labeled as "Indication # 2". The QA Inspector had observed on the previous day shift that WID # S53 (Jerry Shepherd) had started the Flux Core Arc Welding (FCAW) on this repair # 2 and that OIW QC Inspector Jose' Salazar had been present to monitor the welding activities.

Lead QC Inspector Gregson explained that during the FCAW on this interior weld repair, Swing Shift QC Inspector Gary Mundt had randomly verified the welding parameters and pre-heat temperature, during the in-process FCAW being performed by WID # V7. QC Inspector Gregson explained that the parameters and pre-heat were in compliance to the applicable Welding Procedure Specification (WPS 3048). QC Inspector Gregson explained that after the parameters and pre-heat were verified by QC Inspector Mundt, that QC Inspector Mundt then randomly verified that the filler metal being used was in compliance to the applicable WPS 3048. QC Inspector Gregson explained that during the check of the filler metal, QC Inspector Mundt determined that the filler metal was not in compliance to the WPS 3048. QC Inspector Gregson then explained that the filler metal which was used for the interior weld repair # 2, was designated as an E8X Electrode Classification, as verified by QC Inspector Mundt. The QA Inspector noted that per the applicable WPS 3048 which was utilized for the repair, E9X Electrode Classification is listed for the consumable to be used. QC Inspector Gregson explained that QC Inspector Mundt had discovered this at the completion of the weld repair # 2 and notified WID # V7 of the discrepancy.

The QA Inspector then spoke with OIW QC Jose' Salazar on this date, who was present during the FCAW on day shift, on this weld repair # 2. QC Inspector Salazar explained that he had intermittently monitored the welding parameters and pre heat temperatures, at each half-hour of welding time and these were in compliance with the applicable WPS 3048. QC Inspector Salazar explained that he had then verified the 24 hrs. exposure time on the filler metal, to also be in compliance. QC Inspector Salazar explained that due to the position of the filler metal spool at the time, he was not able to physically verify the correct filler metal specification on the spool label, which was being used for the FCAW repair. QC Inspector Salazar explained that WID # S53 had picked up the E8X spool of filler material which had been inadvertently placed on the rolls of E9X spools, in the connex which is utilized for storage. QC Inspector Salazar explained that the identical spool of filler metal was left on the FCAW machine, which was then utilized by WID # V7, on swing shift to continue with the repair.

QC Inspector Gregson explained that a second weld repair was also performed on Swing Shift by WID # V7 on the exterior of the Weld Joint # W4-01, later in the shift. The QA Inspector noted that per the completed OIW Ultrasonic Testing Report (# 2244-10-UT-04), this non-critical repair was plotted and labeled as "Indication # 1". QC Inspector Gregson explained that prior to performing the Flux Core Arc Welding on this repair, that QC Inspector Mundt had verified that the filler metal being used was in compliance to the WPS 3048. QC Inspector Gregson explained that a Critical Weld Repair and a QC Non-Conformance report will be generated. QC Inspector Gregson explained that the weld repair # 2, in which the incorrect filler metal was used, will be excavated out and re-welded, utilizing the correct filler metal.

The QA Inspector then informed Lead QA Inspector Joe Adame about this conversation with Lead QC Inspector Mike Gregson. Lead QA Inspector Adame later informed the QA Inspector that he had spoken with QCM Tom Tomovick regarding this and advised Mr. Tomovick that a Critical Weld Repair should not be needed for this, as it is a second time excavation on the weld joint and the depth of the excavation will not exceed 65 % of the thickness. Lead QA Inspector Adame explained to the QA Inspector that Mr. Tomovick agreed with this being a non-critical weld repair (WRR) and that a QC Corrective Action report will also be generated with the WRR. QA Inspector Adame explained that since OIW QC is generating a Corrective Action report with the WRR, that QA will not generate a Non-Conformance Report, regarding this.

WRR and Corrective Action for this. QC Inspector Mundt explained to the QA Inspector that the applicable WPS 3048 will be listed on the WRR instead of "an approved WPS", which was listed on the WRR originally. QC Inspector Mundt explained that the WRR will include specific instructions to carbon arc and grind the excavation 5 mm past the original depth, length and width, to insure removal of the incorrect filler metal, which was used. QC Inspector Mundt explained that production personnel will not proceed with this repair, until the WRR and Corrective Action is completed, by QCM Tomovick.

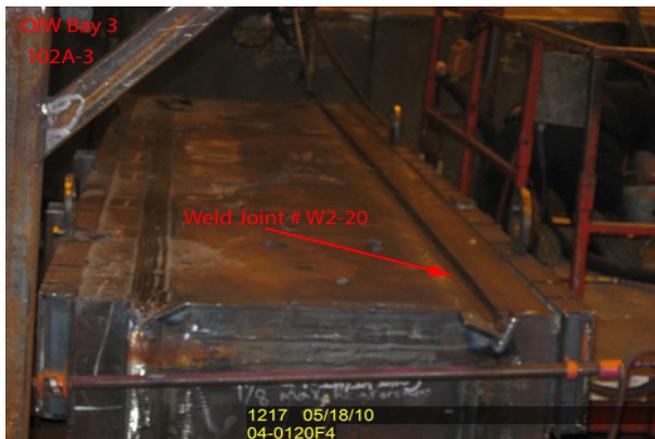
The QA Inspector observed WID # B62 (Marcus Belgarde) performing submerged Arc Welding (SAW) on weld joint (W2-20). The QA Inspector observed that WID # B62 was performing the SAW in the flat position and was currently qualified for this. The QA Inspector noted that this weld joint was a partial penetration, AWS D1.5 TC-P4-S, a110 Base Cap plate to a106 HPS 485 W stiffener. The QA Inspector observed that OIW QC Inspector Jose' Salazar was present at the time of welding and QC Inspector Salazar explained that he was intermittently checking the welding parameter amps, volts, travel speed and pre-heat temperatures. The QA Inspector randomly observed QC Inspector verify welding amperage of 588 amps, 33 volts and a travel speed of 20 inches per minute. The QA Inspector observed that the fill passes were currently in process and that the parameters were in

compliance with the applicable Welding Procedure Specification (WPS) 4020. The QA Inspector then randomly performed a pre-heat check and noted that the temperature was approximately 350 degrees Fahrenheit.

The QA Inspector was present on this swing shift and observed WID # V7 (Vinny Vue) performing Submerged Arc welding on the above mentioned weld joint. The QA Inspector observed that OIW QC Inspector Gary Mundt was present and QC Inspector Mundt explained that the welding parameters were recorded as follows: 680 amps, 35 volts and a travel speed of 22 inches per minute. QC Inspector Mundt explained that pre-heat was recorded at 350 degrees Fahrenheit and the QA Inspector randomly verified this. QC Inspector Mundt explained that the SAW will probably continue the entire shift and he will be present to intermittently monitor the welding activities. The QA Inspector noted that the above mentioned SAW appears to be in compliance with the applicable WPS. See attached picture below.
