DEPARTMENT OF TRANSPORTATION

Contract #: 04-0120F4Cty: SF/ALA Rte: 80 PM: 13.2/13.9File #: 69.28**WELDING INSPECTION REPORT****Resident Engineer:** Pursell, Gary**Address:** 333 Burma Road**City:** Oakland, CA 94607**Report No:** WIR-014081**Date Inspected:** 08-Mar-2010**Project Name:** SAS Superstructure**OSM Arrival Time:** 700**Prime Contractor:** American Bridge/Fluor Enterprises, a JV**OSM Departure Time:** 1900**Contractor:** Zhenhua Port Machinery Company, Ltd (ZPMC), Changxing Island **Location:** Shanghai, China

WELDING INSPECTION REPORT

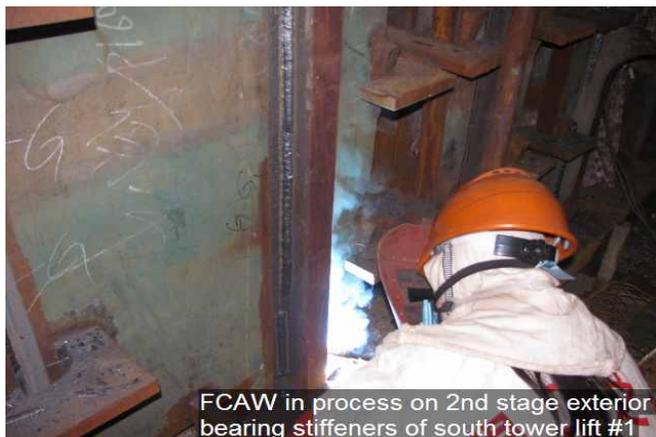
South tower lift #1 bearing stiffeners: - Caltrans QA Inspector observed six ZPMC welders in process FCAW process on 2nd stage exterior bearing stiffeners for skin C of south tower lift #1. The welds ID are SSD1-SA17-F/G-78/68/56/42//38/10. The material used for the 2nd stage exterior bearing stiffeners was reported by ZPMC QC as ASTM a 709M-345 plate with 60mm wall thickness. The weld is designed PJP weld use ZPMC joint detail WT10 with welded in 3G position. The bearing stiffeners weld joint has been pre heat prior welding. The FCAW was monitored and recorded by ZPMC and ABF QC inspector. Based on Caltrans QAI observations, no discrepancies were noted.

FCAW in process on 2nd stage exterior bearing stiffeners of south tower lift #1

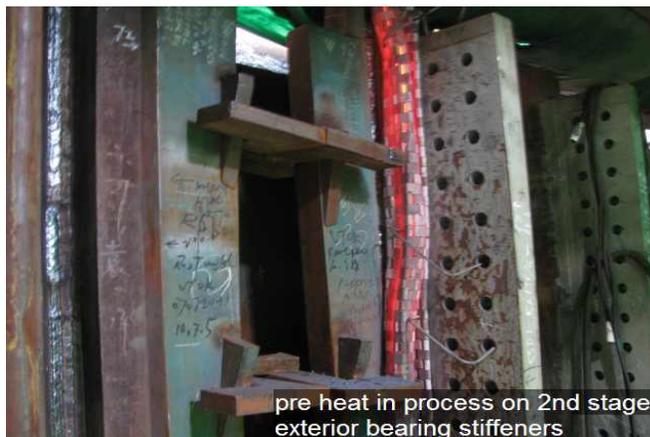
as ASTM a 709M-345 plate with 60mm wall thickness. The weld is designed PJP weld use ZPMC joint detail WT10 with welded in 3G position. The bearing stiffeners weld joint has been pre heat prior welding. The FCAW was monitored and recorded by ZPMC and ABF QC inspector. Based on Caltrans QAI observations, no discrepancies were noted.

pre heat in process on 2nd stage exterior bearing stiffeners

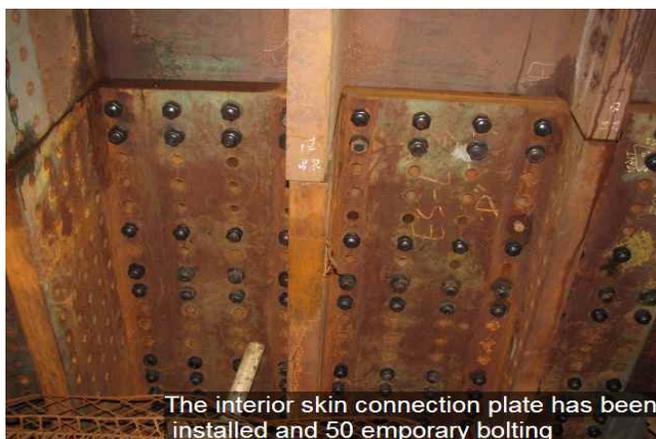
Caltrans QA inspector observed twenty ZPMC workers in process of temporary bolting to the interior skin connection plates which connected to skin plate A, B, C, D and E of north, south, east and west tower lift #1 and lift #2. The ZPMC will install only 50% bolts on each skin connection plate. The temporary bolting of interior skin connection plates have not been completed will be schedule continue tomorrow.

The interior skin connection plate has been installed and 50 temporary bolting

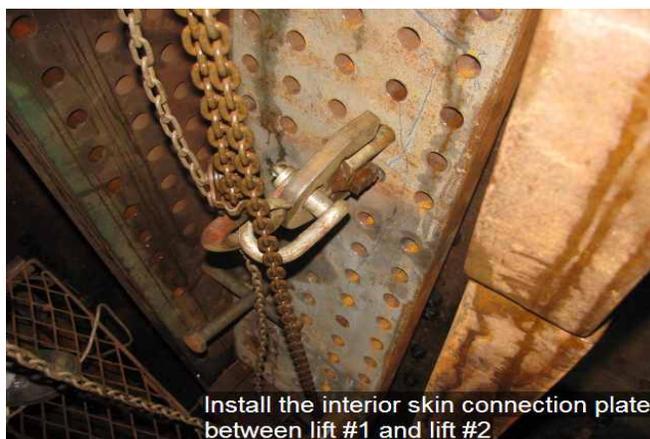
Install the interior skin connection plate between lift #1 and lift #2
