DEPARTMENT OF TRANSPORTATION

Contract #: 04-0120F4Cty: SF/ALA Rte: 80 PM: 13.2/13.9File #: 1.28**WELDING INSPECTION REPORT****Resident Engineer:** Pursell, Gary**Address:** 333 Burma Road**City:** Oakland, CA 94607**Report No:** WIR-014174**Date Inspected:** 18-May-2010**Project Name:** SAS Superstructure**OSM Arrival Time:** 1100**Prime Contractor:** American Bridge/Fluor Enterprises, a JV**OSM Departure Time:** 1930**Contractor:** American Bridge/Fluor Enterprises, a JV**Location:** Job Site**CWI Name:** See Below**CWI Present:** Yes No**Inspected CWI report:** Yes No N/A**Rod Oven in Use:** Yes No N/A**Electrode to specification:** Yes No N/A**Weld Procedures Followed:** Yes No N/A**Qualified Welders:** Yes No N/A**Verified Joint Fit-up:** Yes No N/A**Approved Drawings:** Yes No N/A**Approved WPS:** Yes No N/A**Delayed / Cancelled:** Yes No N/A**Bridge No:** 34-0006**Component:** Orthotropic Box Girders**Summary of Items Observed:**

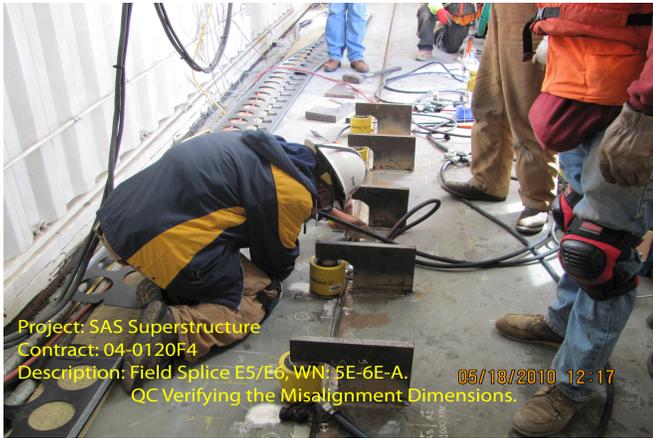
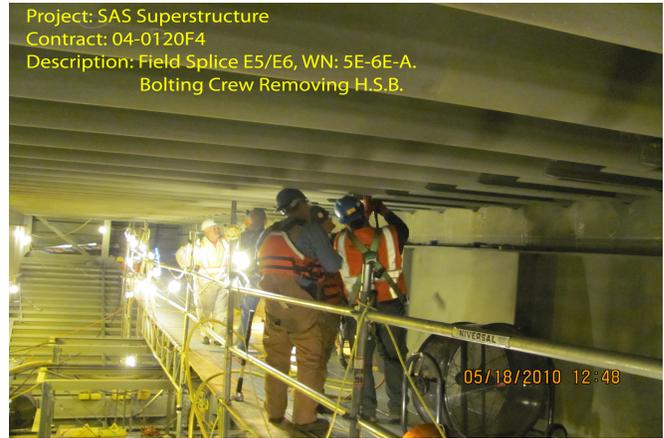
The QAI observed the AB/F personnel attempting to correct the misalignment issue located at the deck plate field splice identified as WN: 5E-6E-A. The Y-dimension was noted as 8,540mm to 11,000mm at the A2 Segment. Prior to performing this task the AB/F personnel changed the hydraulic system from the use of five (5) individual pumps to one (1) pump utilizing a manifold to supply the five individual rams. At the conclusion of revising the set-up, the contractor commence the first phase of correcting the misalignment task by applying hydraulic pressure to 2500 psi, which equates to approximately 60 tons of working pressure at the rams. At this time, the QAI observed the Quality Control Inspector, Bonifacio Daquinag, Jr. verified the dimensions of the misalignment and no changes were noted. At the conclusion of this task the AB/F personnel were instructed by John Callahan to perform the second phase of the operation which was to relieve the tension from the High Strength Bolts (HSB) connecting the U-ribs at the field splice. Upon the completion of this phase additional pressure was applied to 3,000 psi, (approximately 75 tons) utilizing the hydraulic system. At the conclusion of phase two (2) of this operation, the QC inspector verified the dimensions and no significant changes were noted by the QAI, approximately .7mm was recorded and verified at one area and the remaining areas were measured at .5mm. The greatest misalignment was 4.5mm and the least dimension was 2mm. At this time Mr. Callahan instructed the working crew of four (4)

AB/F personnel to tension the H.S.B that were previously relieved of their tension values and to also place steel wedges between the deck plate and the U-rib splice plate at the E5 Orthotropic Box Girder (OBG). At this time Mr. Callahan terminated this operation and informed the QAI that AB/F had completed the task as requested and would await instructions from Cal Trans as how to proceed. Prior to the removal of the temporary attachments the QAI verified the multi-pass fillet welds and no linear indications were noted at the weld metal or the base metal. Note: Cal Trans Engineer Paul Jefferson also observed this operation performed by AB/F.
