DEPARTMENT OF TRANSPORTATION

Contract #: 04-0120F4Cty: SF/ALA Rte: 80 PM: 13.2/13.9File #: 1.28**WELDING INSPECTION REPORT****Resident Engineer:** Pursell, Gary**Address:** 333 Burma Road**City:** Oakland, CA 94607**Report No:** WIR-014179**Date Inspected:** 18-May-2010**Project Name:** SAS Superstructure**OSM Arrival Time:** 630**Prime Contractor:** American Bridge/Fluor Enterprises, a JV**OSM Departure Time:** 1500**Contractor:** American Bridge/Fluor Enterprises, a JV**Location:** Job Site**CWI Name:** Bnifacio Daquinag**CWI Present:** Yes No**Inspected CWI report:** Yes No N/A**Rod Oven in Use:** Yes No N/A**Electrode to specification:** Yes No N/A**Weld Procedures Followed:** Yes No N/A**Qualified Welders:** Yes No N/A**Verified Joint Fit-up:** Yes No N/A**Approved Drawings:** Yes No N/A**Approved WPS:** Yes No N/A**Delayed / Cancelled:** Yes No N/A**Bridge No:** 34-0006**Component:** SAS OBG 5E/6E-A**Summary of Items Observed:**

5E/6E-A

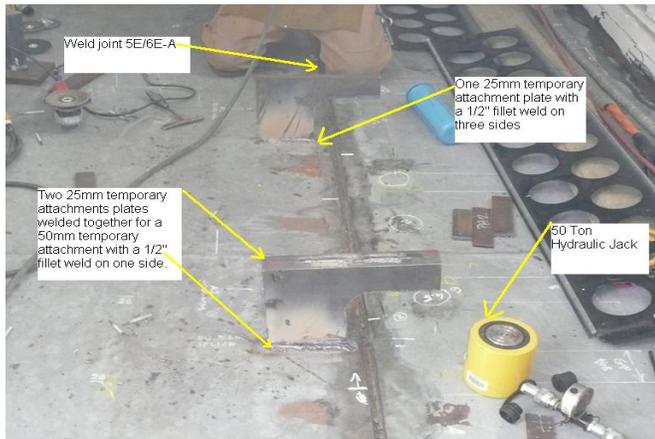
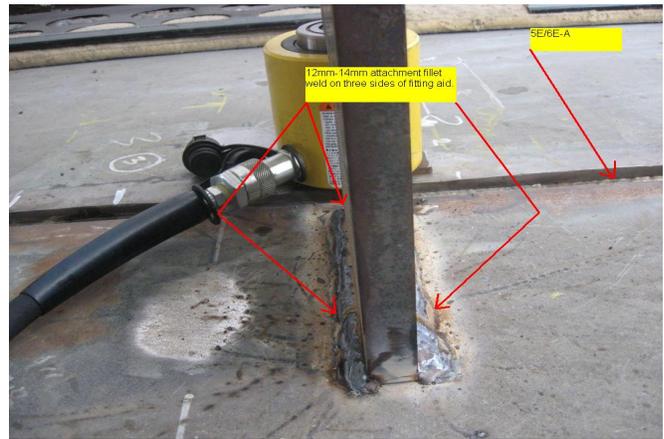
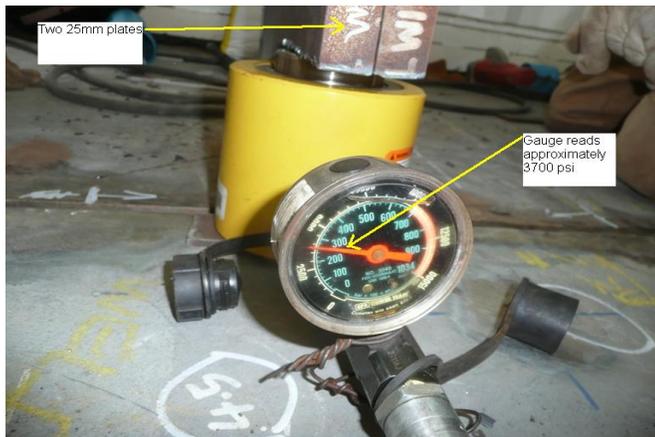
second attempt consisted of two 25mm plates welded together (pictured below) with a 1/2" fillet weld on one side

2nd attachment location Y=8800mm-8850mm (location of the attachment) with a 1/2" fillet on one side. , the QA Inspector observed the gauge on the jack was reading approximately 3500 PSI when the fillet weld failed and was no longer effective. The QA Inspector observed the QC Inspector perform measurements of the misalignment while the plates were under the force of the jack and noted that it appeared to deflect the plate approximately 1mm. The measurement prior to applying force was 3mm and was cut to 2mm under the load of the hydraulic ram. After the 1/2" fillet weld failed, the plates returned to the original position of 3mm total misalignment.

In addition no other temporary attachments had force applied to them before lunch. The QA Inspector observed the ABF welders install 4 additional "dogs" or temporary attachments in a row at the following locations: Y=8560mm-8535mm, Y=9070mm-9120mm, Y=9805mm-9783mm and Y=10330mm-10280mm. I observed the attachments installed at the Y locations noted above were not two plates welded together, rather they were 25mm plate with a 1/2" fillet weld on three sides which appears to be a direct non conformance with the temporary fitting aid procedure previously submitted by ABF and approved by the department. The QA Inspector noted an Incident Report will be generated for the non conforming issue described above. In addition there appear to be two areas of the top deck plate in which ABF is attempting to correct the planar misalignment issue, in which both areas have dimensions that exceed 4mm total misalignment and no more than 6mm total misalignment. Those areas are between Y locations 8640mm-9120mm and 22710mm-23000mm.
