DEPARTMENT OF TRANSPORTATION

Contract #: 04-0120F4Cty: SF/ALA Rte: 80 PM: 13.2/13.9File #: 69.28**WELDING INSPECTION REPORT****Resident Engineer:** Pursell, Gary**Address:** 333 Burma Road**City:** Oakland, CA 94607**Report No:** WIR-014297**Date Inspected:** 15-May-2010**Project Name:** SAS Superstructure**OSM Arrival Time:** 700**Prime Contractor:** American Bridge/Fluor Enterprises, a JV**OSM Departure Time:** 1900**Contractor:** Zhenhua Port Machinery Company, Ltd (ZPMC), Changxing Island **Location:** Shanghai, China

WELDING INSPECTION REPORT

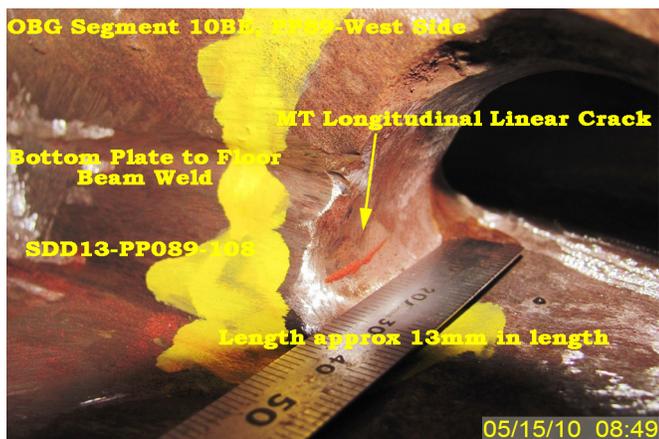
Quality Assurance (QA) Inspectors discovered a total of one (1) Transverse linear Indications and one (1) Longitudinal linear Indications measuring approximately 5 mm and 13 mm in length. One (1) Transverse indication, approximately 5mm in length at Panel Point 89 (East side), in the weld designated as SEG062B-010, joining Floor Beam Flange FB16A (X7J) to Longitudinal Diaphragm LD1A (X75F). One (1) Longitudinal indication, approximately 13mm in length at Panel Point 89 (West side), in the weld designated as SSD13-PP89-108, joining Floor Beam FB16A (X94E) to Bottom Panel BP184A (PL828A). All the welds are Non Seismic Performance Critical Material (Non SPCM). The indications are marked clearly near the weld. OBG segment 10BE is located in outside yard, North of Blast Shop. The Notice of Witness Inspection (NWIT) Number is 005723. The indications are located inside the area previously tested and accepted by ZPMC personnel.
