**DEPARTMENT OF TRANSPORTATION**

Contract #: 04-0120F4Cty: SF/ALA Rte: 80 PM: 13.2/13.9File #: 1x.28**WELDING INSPECTION REPORT****Resident Engineer:** Pursell, Gary**Address:** 333 Burma Road**City:** Oakland, CA 94607**Report No:** WIR-014303**Date Inspected:** 19-May-2010**Project Name:** SAS Superstructure**OSM Arrival Time:** 1000**Prime Contractor:** American Bridge/Fluor Enterprises, a JV**OSM Departure Time:** 1830**Contractor:** American Bridge/Fluor Enterprises, a JV**Location:** Job Site

# WELDING INSPECTION REPORT

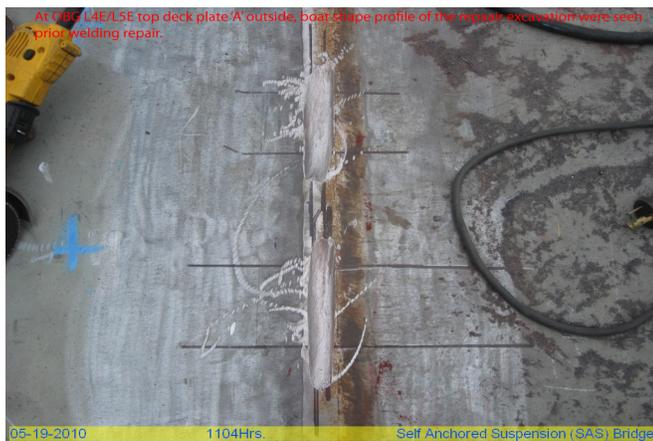
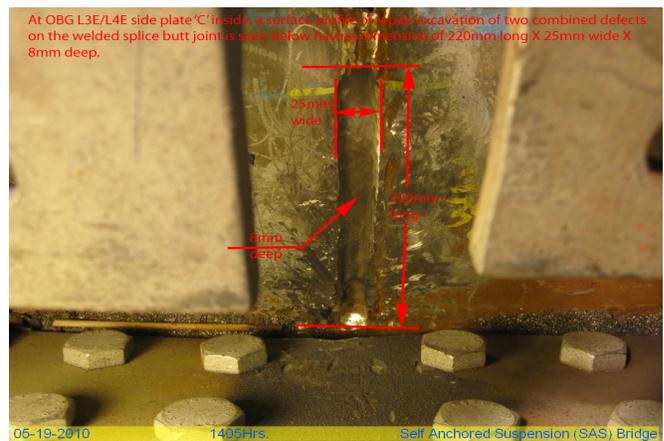
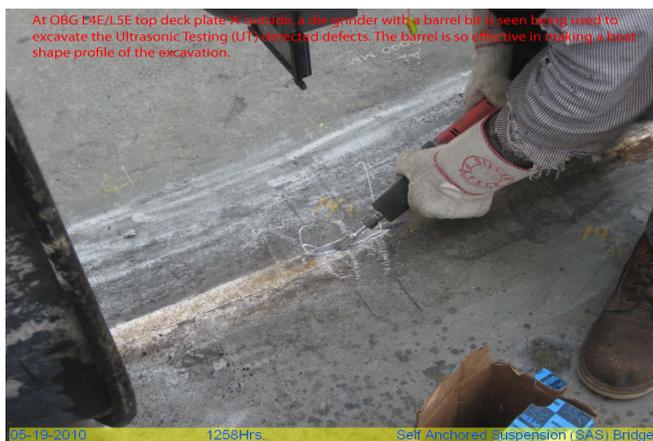
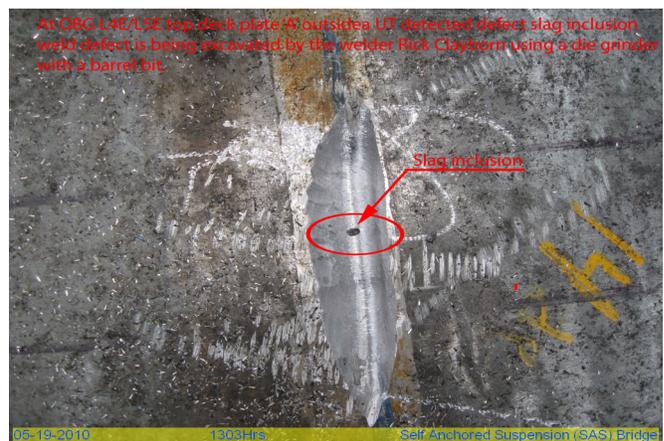
At OBG L3E/L4E side plate 'C2' inside, QA randomly observed ABF/JV qualified welder Mitch Sittinger continue perform CJP groove welding repair. The welder was observed welding in the 3G (vertical) position utilizing Shielded Metal Arc Welding (SMAW) with 1/8" diameter E7018H4R electrode implementing welding procedure ABF-WPS-D15-1000-Repairs. The repair excavations were preheated to more than 140 degree Fahrenheit using propane gas torch prior welding. During the shift, ABF QC William Sherwood was noted monitoring the welder. Prior welding, ABF QC William Sherwood was also observed performing Magnetic Particle Testing (MT) using Parker Contour Probe with red magnetic powder as detecting media on the repair excavation. During the shift, the welder has completed five welding repairs inside and that should complete all the repair works on this splice butt joint inside and outside.

At OBG L4E/L5E top deck plate 'A' outside, QA randomly observed ABF/JV qualified welder Rick Clayborn ID # 2773 perform CJP groove welding repair. The welder was observed welding in the 1G (flat) position utilizing Shielded Metal Arc Welding (SMAW) with 5/32" diameter E7018H4R electrode implementing welding procedure ABF-WPS-D15-1000-Repairs. The repair excavations were preheated to more than 140 degree Fahrenheit using propane gas torch prior welding. During the shift, ABF QC Jesse Cayabyab was noted monitoring the welder. Prior welding, ABF QC Jesse Cayabyab was also observed performing Magnetic Particle Testing (MT) using Parker Contour Probe with red magnetic powder as detecting media on the repair excavation. During the shift, the

welder has completed three welding repairs and was working on the fourth repair at the end of the shift. While welding repair is being done on the deck plate, ABF QC Jesse Cayabyab and Tom Pasqualone were noted performing Ultrasonic Testing (UT) on area A1 and A2 of the same plate respectively. QC Tom Pasqualone informed this QA that as of now they have found a total 14 UT repairs for the areas that have been UT'd on this welded splice butt joint.

At L5E/L6E top deck plate 'A' outside, work activities in this location remain idle after the removal of the welded temporary jigs for porta lift/ram and performing Non Destructive Testing (Magnetic Particle Testing and UT/plate lamination check) by ABF QC on their removal. According to ABF QC Bonifacio Daquinag, ABF is waiting further information on the outcome of the unacceptable misalignment that was noted during fit up.
