**DEPARTMENT OF TRANSPORTATION**

Contract #: 04-0120F4Cty: SF/ALA Rte: 80 PM: 13.2/13.9File #: 1x.28**WELDING INSPECTION REPORT****Resident Engineer:** Pursell, Gary**Address:** 333 Burma Road**City:** Oakland, CA 94607**Report No:** WIR-014330**Date Inspected:** 21-May-2010**Project Name:** SAS Superstructure**OSM Arrival Time:** 1100**Prime Contractor:** American Bridge/Fluor Enterprises, a JV**OSM Departure Time:** 1800**Contractor:** American Bridge/Fluor Enterprises, a JV**Location:** Job Site**CWI Name:** Tony Sherwood**CWI Present:** Yes No**Inspected CWI report:** Yes No N/A**Rod Oven in Use:** Yes No N/A**Electrode to specification:** Yes No N/A**Weld Procedures Followed:** Yes No N/A**Qualified Welders:** Yes No N/A**Verified Joint Fit-up:** Yes No N/A**Approved Drawings:** Yes No N/A**Approved WPS:** Yes No N/A**Delayed / Cancelled:** Yes No N/A**Bridge No:** 34-0006**Component:** OBG Sections**Summary of Items Observed:**

## WELDING INSPECTION REPORT

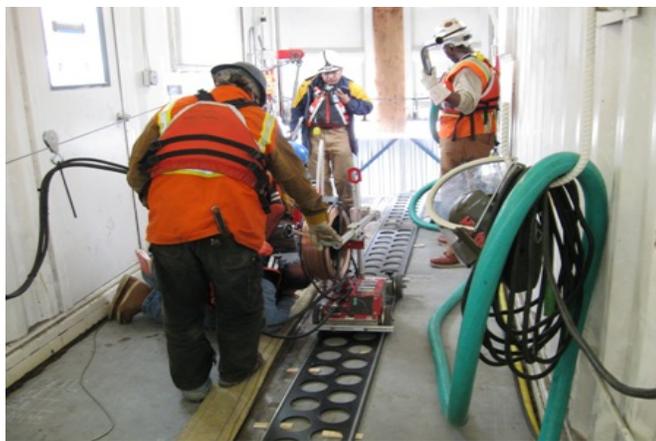
This QA Inspector observed both ABF welding personnel Danny Ieraci (#3232) and Jordan Hazelaar (#2135) were present to start the second SAW weld pass at weld joint E5/E6-A1 thru A5. Welding personnel Danny Ieraci (#3232) started at the center of weld section A3 and progressed towards A1 as ABF welding personnel Jordan Hazelaar (#2135) started at the same location and progressed towards weld section A5. This QA Inspector observed QC Inspector Tony Sherwood was present and monitoring Jordan Hazelaar (#2135) and QC Inspector

Bonifacio Daquinag Jr. was present and monitoring Danny Ieraci (#3232). Please see photo below welding in progress.
