DEPARTMENT OF TRANSPORTATION

Contract #: 04-0120F4Cty: SF/ALA Rte: 80 PM: 13.2/13.9File #: 69.28**WELDING INSPECTION REPORT****Resident Engineer:** Pursell, Gary**Address:** 333 Burma Road**City:** Oakland, CA 94607**Report No:** WIR-014377**Date Inspected:** 11-May-2010**Project Name:** SAS Superstructure**OSM Arrival Time:** 700**Prime Contractor:** American Bridge/Fluor Enterprises, a JV**OSM Departure Time:** 1900**Contractor:** Zhenhua Port Machinery Company, Ltd (ZPMC), Changxing Island **Location:** Shanghai, China**CWI Name:****CWI Present:**

Bridge No: 34-0006**Component:** OBG Trial Assembly**Summary of Items Observed:**

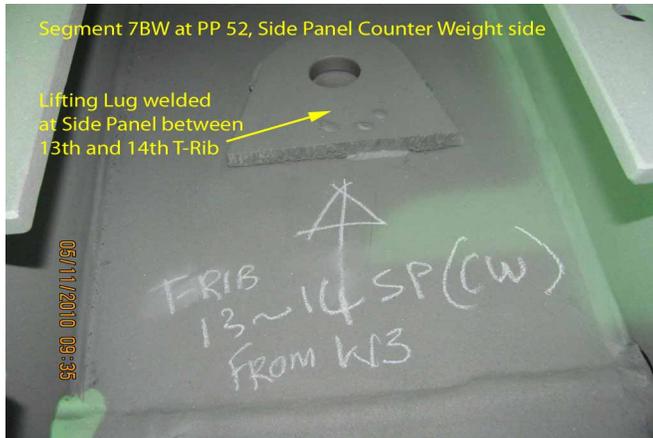
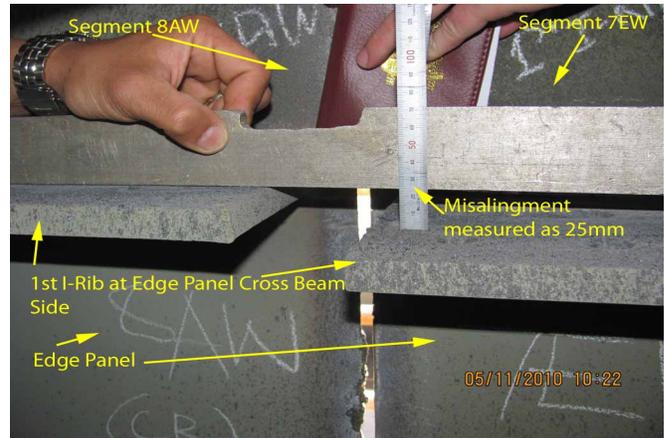
During Quality Assurance (QA) random in-process visual inspection this QA inspector observed at Segment 7EW to 8AW between PP 60 to PP61 Corner Assembly Edge Panel I-Stiffener are misaligned by 25mm and 28mm

This QA Inspector observed during random visual inspection misaligned Edge Panel Stiffener between Segment 7EW to 8AW (PP 60 and PP61) the deformation for 1st I-Rib measured as 25mm and misalignment at 2nd I-Rib measured as 28mm. The measured and recorded readings were submitted to the Lead and Engineer for review. Please refer the pictures attached below for more comprehensive details.
