DEPARTMENT OF TRANSPORTATION

Contract #: 04-0120F4Cty: SF/ALA Rte: 80 PM: 13.2/13.9File #: 69.28**WELDING INSPECTION REPORT****Resident Engineer:** Pursell, Gary**Address:** 333 Burma Road**City:** Oakland, CA 94607**Report No:** WIR-014378**Date Inspected:** 12-May-2010**Project Name:** SAS Superstructure**OSM Arrival Time:** 700**Prime Contractor:** American Bridge/Fluor Enterprises, a JV**OSM Departure Time:** 1900**Contractor:** Zhenhua Port Machinery Company, Ltd (ZPMC), Changxing Island **Location:** Shanghai, China**CWI Name:****CWI Present:****Yes No****Inspected CWI report:** **Yes No N/A****Rod Oven in Use:****Yes No N/A****Electrode to specification:** **Yes No N/A****Weld Procedures Followed:****Yes No N/A****Qualified Welders:** **Yes No N/A****Verified Joint Fit-up:****Yes No N/A****Approved Drawings:** **Yes No N/A****Approved WPS:****Yes No N/A****Delayed / Cancelled:****Yes No N/A****Bridge No:** 34-0006**Component:** OBG Trial Assembly**Summary of Items Observed:**

Orthotropic Box Girder (OBG) Trial Assembly Areas

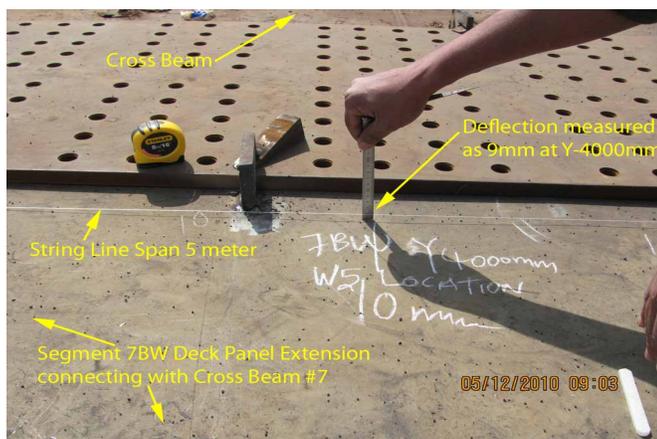
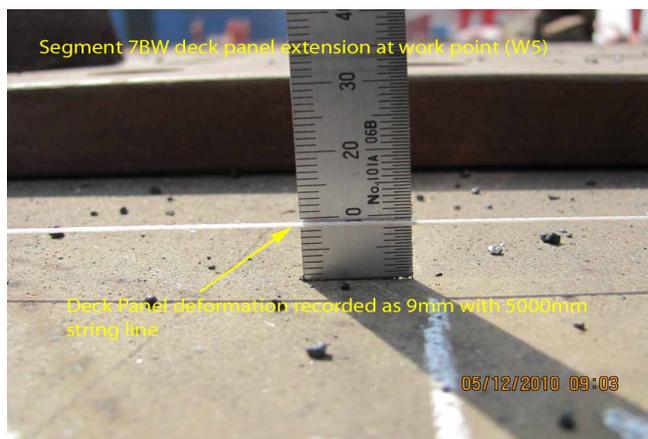
This Quality Assurance (QA) performed dimension Inspection for flatness of Deck Panel Extension of Segment 7BW between PP 50 and PP 51 with 5000mm string line span and observed 10mm deflection at Y=1965mm (datum line reference taken from PP 50). The recorded readings were submitted to the Lead and Engineer for review. Please refer the attached pictures below for more comprehensive details.
