DEPARTMENT OF TRANSPORTATION

Contract #: 04-0120F4Cty: SF/ALA Rte: 80 PM: 13.2/13.9File #: 1.28**WELDING INSPECTION REPORT****Resident Engineer:** Pursell, Gary**Address:** 333 Burma Road**City:** Oakland, CA 94607**Report No:** WIR-014388**Date Inspected:** 25-May-2010**Project Name:** SAS Superstructure**OSM Arrival Time:** 700**Prime Contractor:** American Bridge/Fluor Enterprises, a JV**OSM Departure Time:** 1530**Contractor:** American Bridge/Fluor Enterprises, a JV**Location:** Job Site**CWI Name:** See Below**CWI Present:** Yes No**Inspected CWI report:** Yes No N/A**Rod Oven in Use:** Yes No N/A**Electrode to specification:** Yes No N/A**Weld Procedures Followed:** Yes No N/A**Qualified Welders:** Yes No N/A**Verified Joint Fit-up:** Yes No N/A**Approved Drawings:** Yes No N/A**Approved WPS:** Yes No N/A**Delayed / Cancelled:** Yes No N/A**Bridge No:** 34-0006**Component:** Orthotropic Box Girders (OBG)**Summary of Items Observed:**

1. OBG Field Splice 3E/4E Face C (Inside) VT review
2. OBG Field Splice 3E/4E Face E (Inside) VT review
3. OBG Field Splice 4E/5E Face D (Inside)
4. OBG Field Splice 5E/6E Face A (Outside)
5. OBG Field Splice 2W/3W Face E (Outside)

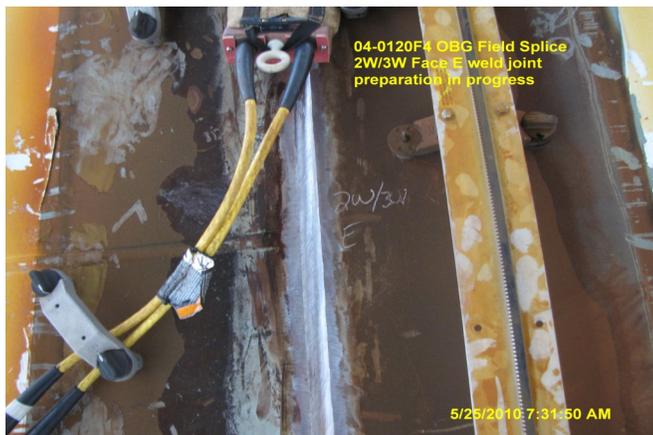
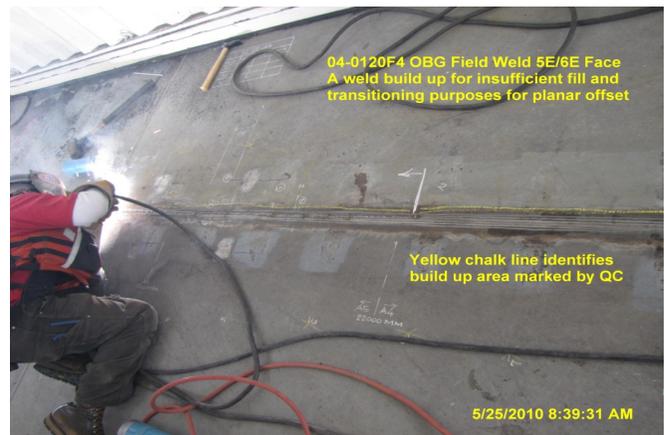
The QA inspector noted and periodically observed ABF welding operators Rory Hogan and Jeremy Dolan performing the grinding/cleaning operations for face E on the second side (Outside). The welding operators continued setting the equipment up and periodically performing the operation throughout the shift with QC inspector Jim Cunningham noted to be present in order to monitor the work and review the cleaned weld joint. A digital photo is included in the body of this report for general information. The work appeared to be progressing in general conformance with the contract documents.
