**DEPARTMENT OF TRANSPORTATION**

Contract #: 04-0120F4Cty: SF/ALA Rte: 80 PM: 13.2/13.9File #: 69.28**WELDING INSPECTION REPORT****Resident Engineer:** Pursell, Gary**Address:** 333 Burma Road**City:** Oakland, CA 94607**Report No:** WIR-014399**Date Inspected:** 21-May-2010**Project Name:** SAS Superstructure**OSM Arrival Time:** 700**Prime Contractor:** American Bridge/Fluor Enterprises, a JV**OSM Departure Time:** 1900**Contractor:** Zhenhua Port Machinery Company, Ltd (ZPMC), Changxing Island **Location:** Shanghai, China

## WELDING INSPECTION REPORT

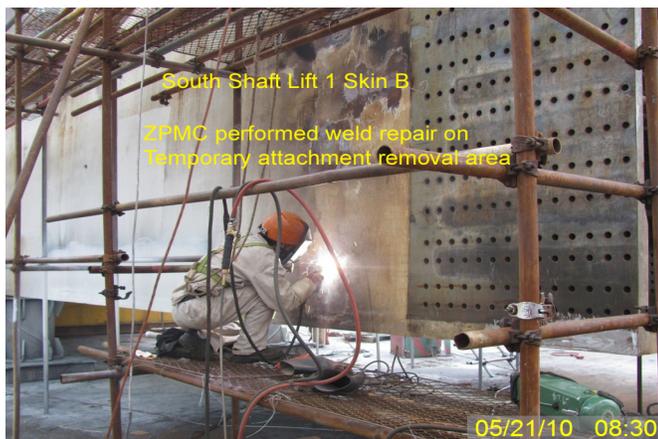
ZPMC performed weld repair on Temporary attachment removal area of South Shaft Lift 1 located on Skin B (47.6M Elevation). The base metal repair areas were approximately 3mm depth and 100mm, 85mm length at 2 random locations. The material is A 709M Grade 345 Non-SPCM. Welder is identified as 500363.ZPMC QC is identified as Mr.Zhu Feng. SMAW welding was been performed against Temporary weld repair report. The welding variables recorded by QC appeared to comply with the WPS-345-SMAW-3G(3F)-Repair.Please see the attached picture.

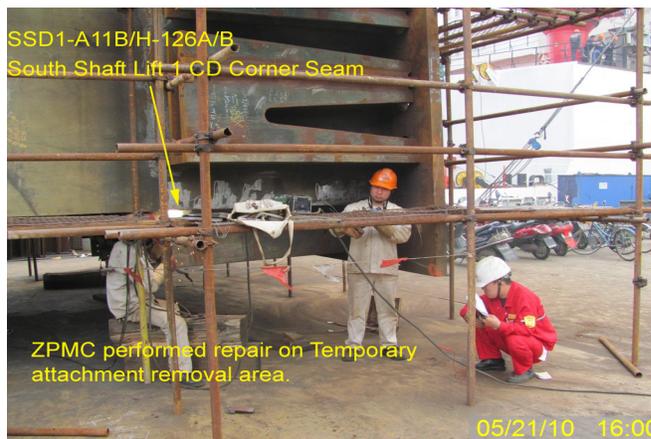
ZPMC performed repair on Temporary attachment removal area. SMAW welding of weld joint no:

SSD1-A11B/H-126A/B located on South Shaft Lift 1 CD Corner Seam. Welder is identified as 040582. ZPMC

CWI is identified as Mr.Qiu wen. SMAW welding was been performed against Temporary weld Repair Report .

The welding variables recorded by QC appeared to comply with the WPS-345-SMAW-4G(4F)-Repair.Please see the attached picture.
