Contract #: 04-0120F4Cty: SF/ALA Rte: 80 PM: 13.2/13.9File #: 13.28**WELDING INSPECTION REPORT****Resident Engineer:** Pursell, Gary**Address:** 333 Burma Road**City:** Oakland, CA 94607**Report No:** WIR-014474**Date Inspected:** 20-May-2010**Project Name:** SAS Superstructure**OSM Arrival Time:** 1000**Prime Contractor:** American Bridge/Fluor Enterprises, a JV**OSM Departure Time:** 1830**Contractor:** Oregon Iron Works Clackamas, Or.**Location:** Clackamas, OR

Bridge No: 34-0006**Component:** Hinge K Pipe Beams**Summary of Items Observed:**

Hinge-K Pipe Beam Assembly 101A-4:

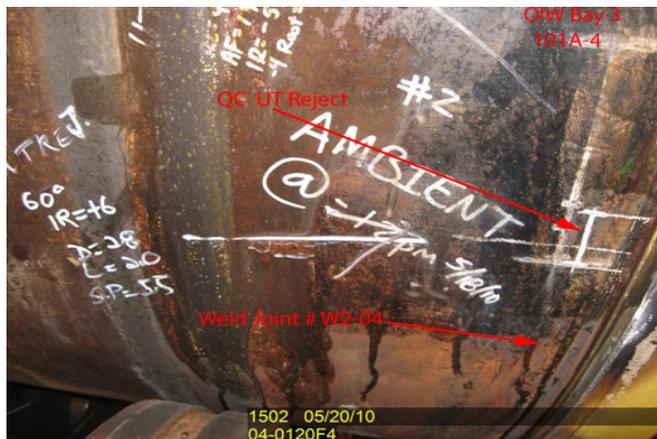
Lead QA Inspector Joe Adame informed the QA Inspector that OIW production had started the non-critical weld repair # 2 (# 2244-10-04), earlier in the a.m. shift. The QA Inspector noted that this was the non-critical weld repair in which the incorrect filler metal, E8X had been utilized for the repair and which OIW will excavate out and re-repair, utilizing the correct E9X filler metal. QA Inspector Adame explained that during the pre-heating, OIW decided to perform Ultrasonic Weld Inspection on the area, to potentially locate defects in the existing non-critical repair, which otherwise might not be excavated out during the removal of the incorrect filler metal. The QA Inspector later observed that the assembly was now idle, pending the area to cool back down to ambient temperature, prior to an OIW QC Inspector performing the UT.

The QA Inspector later observed on swing shift that OIW QC Inspector Rob Walters had performed the UT and had found a rejectable indication in the repair area and had marked the UT information on the part next to the Weld Joint. The QA Inspector observed that Mr. Walters had discovered a + 6 Class B indication, approximately 50 mm long and 70 mm deep, utilizing a 60 degree testing angle. The QA Inspector observed that Mr. Walters had marked a line on the outside of the weld joint in yellow paint marker, where the defect was located. See attached picture.
