DEPARTMENT OF TRANSPORTATION

Contract #: 04-0120F4Cty: SF/ALA Rte: 80 PM: 13.2/13.9File #: 13.28**WELDING INSPECTION REPORT****Resident Engineer:** Pursell, Gary**Address:** 333 Burma Road**City:** Oakland, CA 94607**Report No:** WIR-014475**Date Inspected:** 21-May-2010**Project Name:** SAS Superstructure**OSM Arrival Time:** 1000**Prime Contractor:** American Bridge/Fluor Enterprises, a JV**OSM Departure Time:** 1830**Contractor:** Oregon Iron Works Clackamas, Or.**Location:** Clackamas, OR

Bridge No: 34-0006 **Component:** Hinge K Pipe Beams

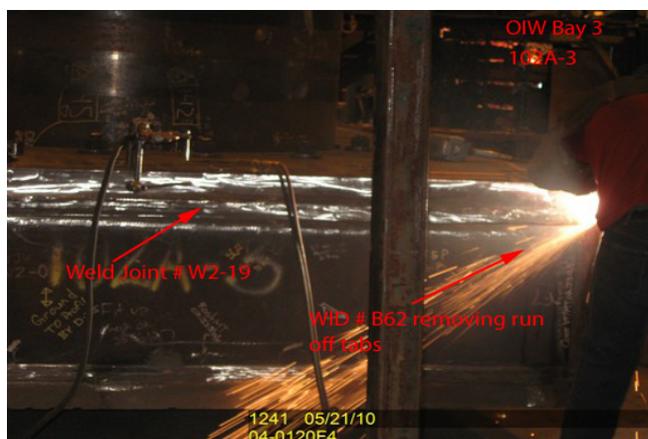
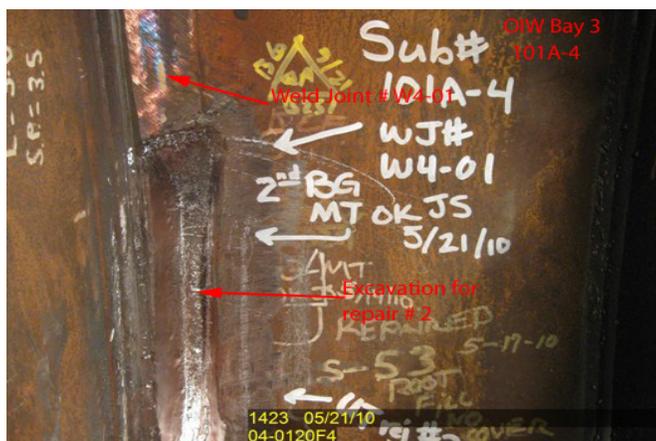
The QA Inspector later observed Mr. Belgarde cutting off the run-off tabs, which were previously utilized for the Submerged Arc Welding on the Partial Joint Penetration (PJP) weld joint # W2-19. The QA Inspector observed that Mr. Belgarde was utilizing an oxygen acetylene cutting torch to roughly cut off the tabs. Once the tabs were cut off, the QA Inspector observed Mr. Belgarde utilizing a hand held Makita brand grinder with an attached 9 " grinding disc. The QA Inspector observed that the excessive metal which was not removed by cutting was being

removed by grinding. The QA Inspector observed that during the entire shift, Mr. Belgarde had performed the grinding on the above mentioned weld joint, which included the removal of excessive weld reinforcement on the cap, which exceed 3 mm. The QA Inspector observed that by end of shift, the assembly is still laying on the Bay 3 shop floor. See attached pictures below.
