DEPARTMENT OF TRANSPORTATION

Contract #: 04-0120F4Cty: SF/ALA Rte: 80 PM: 13.2/13.9File #: 13.28**WELDING INSPECTION REPORT****Resident Engineer:** Pursell, Gary**Address:** 333 Burma Road**City:** Oakland, CA 94607**Report No:** WIR-014479**Date Inspected:** 25-May-2010**Project Name:** SAS Superstructure**OSM Arrival Time:** 1000**Prime Contractor:** American Bridge/Fluor Enterprises, a JV**OSM Departure Time:** 1830**Contractor:** Oregon Iron Works Clackamas, Or.**Location:** Clackamas, OR

CWI Name:	M. Gregson, J. Salazar, G. Mundt	CWI Present:	Yes	No
Inspected CWI report:	Yes No N/A	Rod Oven in Use:	Yes	No N/A
Electrode to specification:	Yes No N/A	Weld Procedures Followed:	Yes	No N/A
Qualified Welders:	Yes No N/A	Verified Joint Fit-up:	Yes	No N/A
Approved Drawings:	Yes No N/A	Approved WPS:	Yes	No N/A
		Delayed / Cancelled:	Yes	No N/A
Bridge No:	34-0006	Component:	Hinge K Pipe Beams

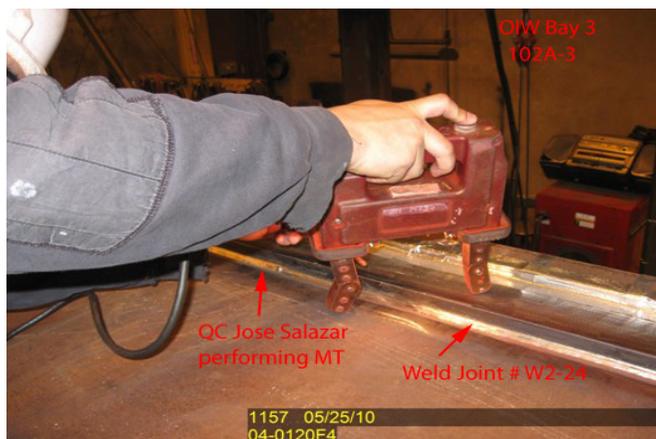
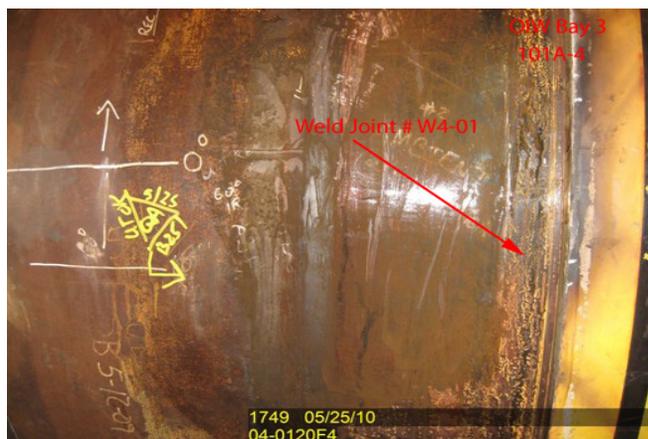
The QA Inspector later observed that the SAW root pass had been completed on the above mentioned weld joint # W2-24 and QC Inspector Salazar was in process of performing Magnetic Particle Testing (MT) on this root pass. QC Inspector explained that he had performed Visual testing, prior to performing the MT and found no rejectable indications. After the MT was complete, QC Inspector Salazar explained that no rejectable indications were found, during the testing and that WID # B62, will be setting up to start the fill passes. The QA Inspector then performed 100% Visual and approximately 50% MT on the weld joint root passes and found no rejectable indications. See attached picture below and completed Magnetic Particle Testing report (TL6028), for additional details.
