**DEPARTMENT OF TRANSPORTATION**

Contract #: 04-0120F4Cty: SF/ALA Rte: 80 PM: 13.2/13.9File #: 1.28**WELDING INSPECTION REPORT****Resident Engineer:** Pursell, Gary**Address:** 333 Burma Road**City:** Oakland, CA 94607**Report No:** WIR-014489**Date Inspected:** 27-May-2010**Project Name:** SAS Superstructure**OSM Arrival Time:** 1100**Prime Contractor:** American Bridge/Fluor Enterprises, a JV**OSM Departure Time:** 1930**Contractor:** American Bridge/Fluor Enterprises, a JV**Location:** Job Site**CWI Name:** See Below**CWI Present:** Yes No**Inspected CWI report:** Yes No N/A**Rod Oven in Use:** Yes No N/A**Electrode to specification:** Yes No N/A**Weld Procedures Followed:** Yes No N/A**Qualified Welders:** Yes No N/A**Verified Joint Fit-up:** Yes No N/A**Approved Drawings:** Yes No N/A**Approved WPS:** Yes No N/A**Delayed / Cancelled:** Yes No N/A**Bridge No:** 34-0006**Component:** Orthotropic Box Girders**Summary of Items Observed:**

## WELDING INSPECTION REPORT

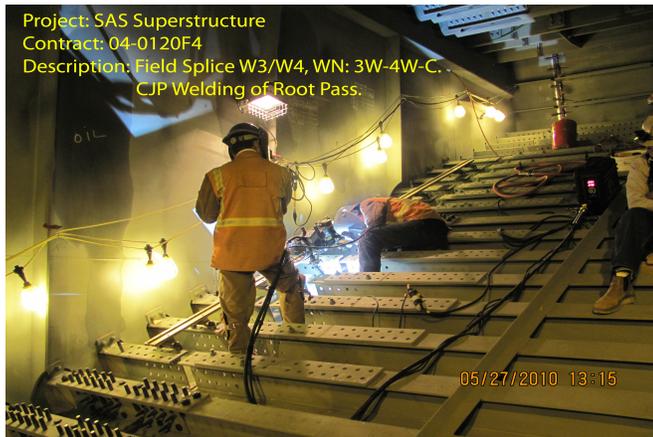
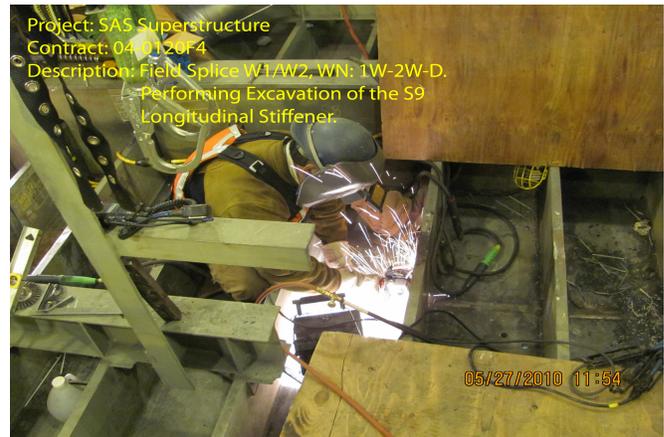
The digital photographs, below, illustrate the work observed during this scheduled shift.
