DEPARTMENT OF TRANSPORTATION

Contract #: 04-0120F4Cty: SF/ALA Rte: 80 PM: 13.2/13.9File #: 1.28**WELDING INSPECTION REPORT****Resident Engineer:** Pursell, Gary**Address:** 333 Burma Road**City:** Oakland, CA 94607**Report No:** WIR-014490**Date Inspected:** 27-May-2010**Project Name:** SAS Superstructure**OSM Arrival Time:** 1000**Prime Contractor:** American Bridge/Fluor Enterprises, a JV**OSM Departure Time:** 1830**Contractor:** American Bridge/Fluor Enterprises, a JV**Location:** Job Site

CWI Name:	Jim Cunningham and William She			CWI Present:	Yes	No	
Inspected CWI report:	Yes	No	N/A	Rod Oven in Use:	Yes	No	N/A
Electrode to specification:	Yes	No	N/A	Weld Procedures Followed:	Yes	No	N/A
Qualified Welders:	Yes	No	N/A	Verified Joint Fit-up:	Yes	No	N/A
Approved Drawings:	Yes	No	N/A	Approved WPS:	Yes	No	N/A
				Delayed / Cancelled:	Yes	No	N/A
Bridge No:	34-0006			Component:	Orthotropic Box Girder

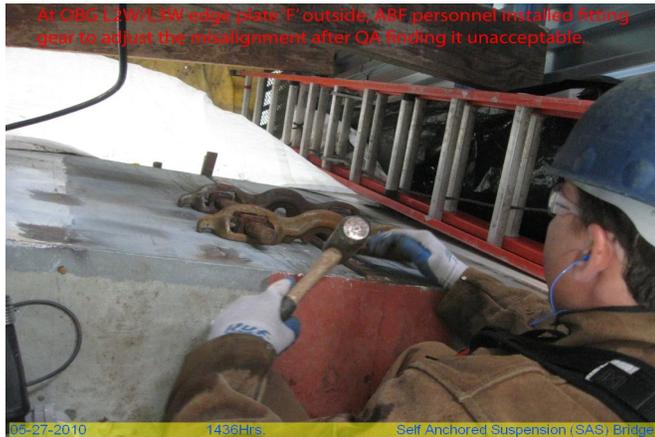
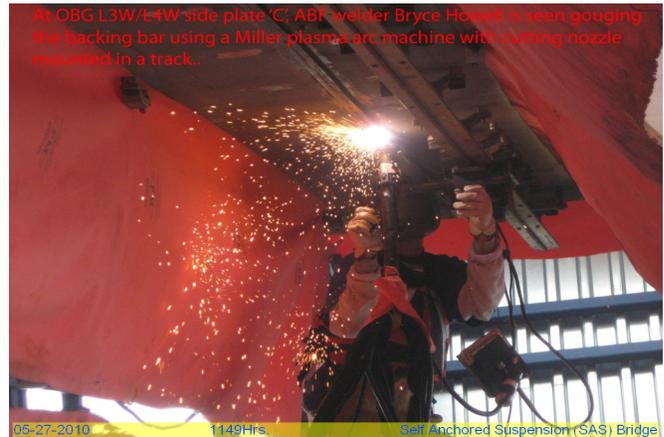
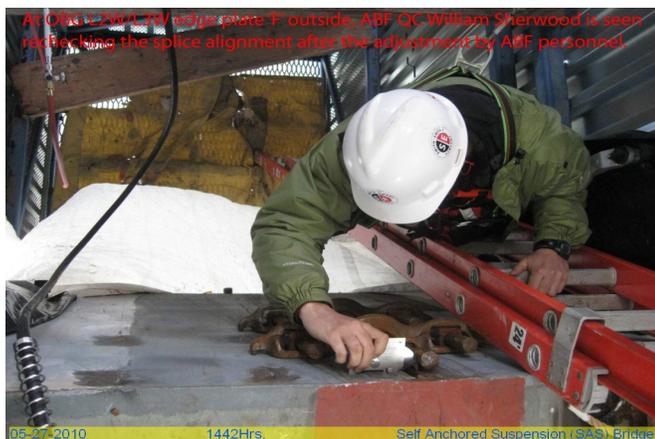
QA randomly observed ABF/JV qualified welders Rory Hogan (ID #3186) continue perform CJP groove (splice) back welding fill pass on Orthotropic Box Girder (OBG) L2W/L3W side plate 'E2' outside. The welder was observed back welding in the 4G (overhead) position utilizing a dual shield Flux Cored Arc Welding (FCAW-G) with E71T-1M, 1/16" diameter wire electrode and implementing Caltrans approved Welding Procedure Specification (WPS) ABF-WPS-D15-3110-4. The welder was using a track mounted welder holder assembly that is remotely controlled. The joint being welded has the backing bar gouged using the Esab Plasma Arc machine and was ground smooth. The gouged and ground splice butt joint was also Non Destructive Testing (NDT) tested using the Magnetic Particle Testing (MT). The splice joint was preheated and maintained to greater than 150 degree Fahrenheit using Miller Proheat 35 Induction Heating System located at the other side of the plate prior/during welding. The vicinity was also properly protected from wind and other climatic conditions. During welding, ABF Quality Control (QC) Jim Cunningham was noted monitoring the welding parameters of the welder.

At OBG L2W/L3W side plate 'C' outside, two ABF welders Bryce Howell and Mike Maday were observed performing back gouging on the splice butt joint of 'C' plate. The personnel were using Esab plasma arc gouging machine with nozzle holder mounted to a track. During the shift, gouging of the backing bar and some of the base metal was not completed and will continue tomorrow.

At OBG L3W/L4W edge plate 'F' outside, new ABF welder Xiao Jian Wan ID# 9677 prepared his welding equipment to perform 3G FCAW-G welding on the splice butt joint. QA had asked ABF QC William Sherwood if the alignment has been checked. QC responded to QA and said it has only 1 to 2mm misalignment. QA verified the alignment and it was noted to be 4.0mm. Due to the observed unacceptable misalignment, ABF personnel have reworked on the fit up by using fitting gears and adjusted the misalignment to acceptable reading.
