DEPARTMENT OF TRANSPORTATION

Contract #: 04-0120F4Cty: SF/ALA Rte: 80 PM: 13.2/13.9File #: 1.28**WELDING INSPECTION REPORT****Resident Engineer:** Pursell, Gary**Address:** 333 Burma Road**City:** Oakland, CA 94607**Report No:** WIR-014502**Date Inspected:** 26-May-2010**Project Name:** SAS Superstructure**OSM Arrival Time:** 630**Prime Contractor:** American Bridge/Fluor Enterprises, a JV**OSM Departure Time:** 1700**Contractor:** American Bridge/Fluor Enterprises, a JV**Location:** Job Site**CWI Name:** See Below**CWI Present:** Yes No**Inspected CWI report:** Yes No N/A**Rod Oven in Use:** Yes No N/A**Electrode to specification:** Yes No N/A**Weld Procedures Followed:** Yes No N/A**Qualified Welders:** Yes No N/A**Verified Joint Fit-up:** Yes No N/A**Approved Drawings:** Yes No N/A**Approved WPS:** Yes No N/A**Delayed / Cancelled:** Yes No N/A**Bridge No:** 34-0006**Component:** Orthotropic Box Girders (OBG)**Summary of Items Observed:**

Field Splice 3E/4E Face C (Outside) Repair

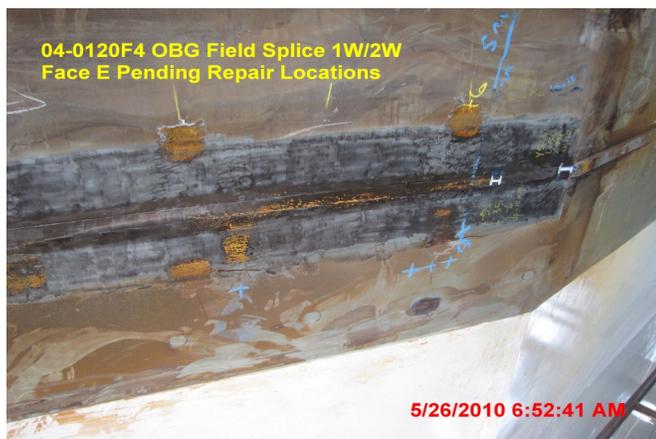
Field Splice 1W/2W Face E (Outside)

The QA inspector reviewed the status of the ultrasonic testing (UT) for the completed weld seam at this location. At this time there 5 locations identified by the QC department for repairs due to rejectable indications discovered during the UT. A digital photo is included in the body of this report for general information. No remedial work was performed at this location during the QA inspectors shift.
