DEPARTMENT OF TRANSPORTATION

Contract #: 04-0120F4Cty: SF/ALA Rte: 80 PM: 13.2/13.9File #: 1.28**WELDING INSPECTION REPORT****Resident Engineer:** Pursell, Gary**Address:** 333 Burma Road**City:** Oakland, CA 94607**Report No:** WIR-014504**Date Inspected:** 01-Jun-2010**Project Name:** SAS Superstructure**OSM Arrival Time:** 1100**Prime Contractor:** American Bridge/Fluor Enterprises, a JV**OSM Departure Time:** 1930**Contractor:** American Bridge/Fluor Enterprises, a JV**Location:** Job Site**CWI Name:** See Below**CWI Present:** Yes No**Inspected CWI report:** Yes No N/A**Rod Oven in Use:** Yes No N/A**Electrode to specification:** Yes No N/A**Weld Procedures Followed:** Yes No N/A**Qualified Welders:** Yes No N/A**Verified Joint Fit-up:** Yes No N/A**Approved Drawings:** Yes No N/A**Approved WPS:** Yes No N/A**Delayed / Cancelled:** Yes No N/A**Bridge No:** 34-0006**Component:** Orthotropic Box Girders**Summary of Items Observed:**

WELDING INSPECTION REPORT

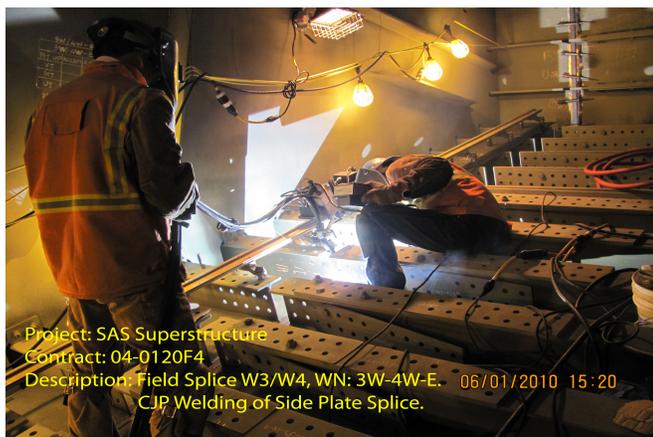
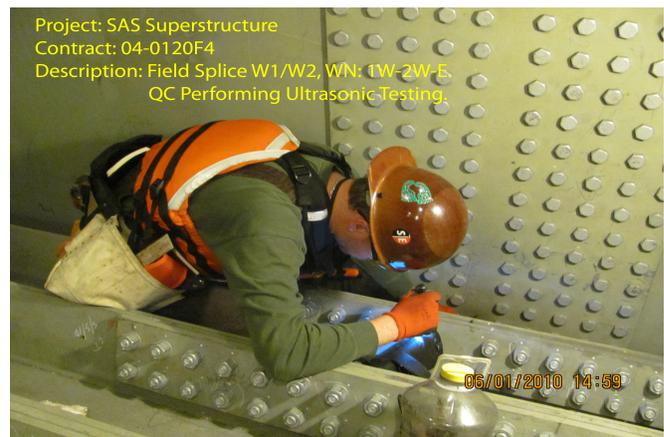
The digital photographs below illustrate the work observed during this scheduled shift.
