Contract #: 04-0120F4Cty: SF/ALA Rte: 80 PM: 13.2/13.9File #: 13.28**WELDING INSPECTION REPORT****Resident Engineer:** Pursell, Gary**Address:** 333 Burma Road**City:** Oakland, CA 94607**Report No:** WIR-014514**Date Inspected:** 01-Jun-2010**Project Name:** SAS Superstructure**OSM Arrival Time:** 1000**Prime Contractor:** American Bridge/Fluor Enterprises, a JV**OSM Departure Time:** 1830**Contractor:** Oregon Iron Works Clackamas, Or.**Location:** Clackamas, OR

CWI Name:	M. Gregson, J. Salazar, G. Mundt	CWI Present:	Yes	No			
Inspected CWI report:	Yes	No	N/A	Rod Oven in Use:	Yes	No	N/A
Electrode to specification:	Yes	No	N/A	Weld Procedures Followed:	Yes	No	N/A
Qualified Welders:	Yes	No	N/A	Verified Joint Fit-up:	Yes	No	N/A
Approved Drawings:	Yes	No	N/A	Approved WPS:	Yes	No	N/A
				Delayed / Cancelled:	Yes	No	N/A
Bridge No:	34-0006	Component:	Hinge K Pipe Beams

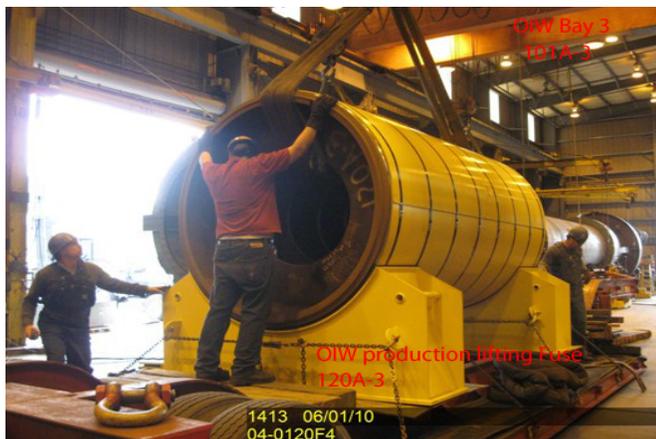
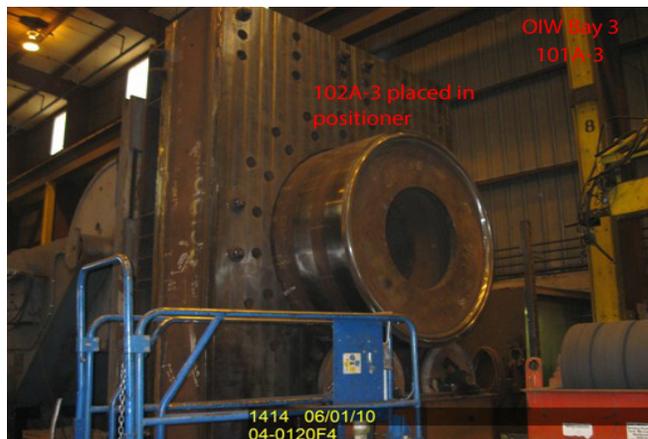
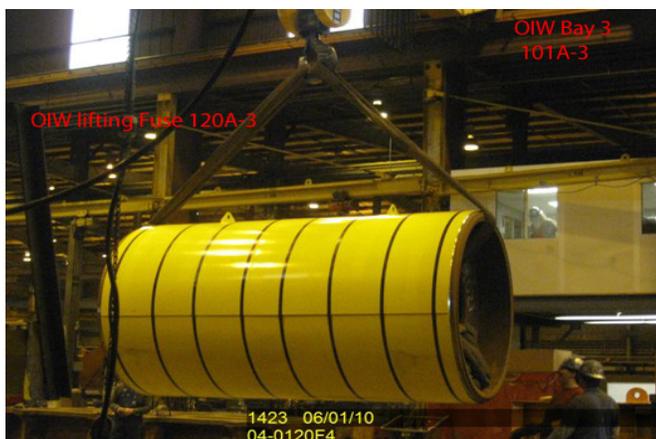
Hinge-K Pipe Beam Assembly 101A-3:

The QA Inspector observed that OIW had placed the Fuse 120A-3 into the Production Bay 3 and the Fuse was sitting idle on a trailer in the Bay.

The QA Inspector later observed OIW production personell attaching two yellow slings through each end of the Fuse and attach the slings to lifting shackles. After the slings and shackles were attached, the QA Inspector observed OIW utilizing the hand held controls which operate the overhead Bay crane, to mobilize the crane over the Fuse. Once the crane was mobilized, the QA Inspector observed the crane cables and lifting hook lowered to attach the slings. Once the slings were attached, the QA Inspector observed OIW production lift the Fuse from the trailer and move to the North and then place on wooden dunnage on the Bay floor, near the Forging assembly 102A-3, which had been previously placed in the welding positioner.

The QA Inspector later observed that OIW had placed the Fuse on the saddles which were used during transport and the Fuse was currently sitting idle.

The QA Inspector observed that OIW Production Lead Troy Smith was present on this shift and Mr. Smith explained that OIW will eventually place this Fuse and begin fitting the Fuse to the Forging, 102A-3. The QA Inspector noted that this will be identified as HPB 102A-3. See attached pictures below.
