**DEPARTMENT OF TRANSPORTATION**

Contract #: 04-0120F4Cty: SF/ALA Rte: 80 PM: 13.2/13.9File #: 69.28**WELDING INSPECTION REPORT****Resident Engineer:** Pursell, Gary**Address:** 333 Burma Road**City:** Oakland, CA 94607**Report No:** WIR-014521**Date Inspected:** 31-May-2010**Project Name:** SAS Superstructure**OSM Arrival Time:** 700**Prime Contractor:** American Bridge/Fluor Enterprises, a JV**OSM Departure Time:** 1900**Contractor:** Zhenhua Port Machinery Company, Ltd (ZPMC), Changxing Island **Location:** Shanghai, China**CWI Name:** Zhou Cheng.**CWI Present:** Yes No**Inspected CWI report:** Yes No N/A**Rod Oven in Use:** Yes No N/A**Electrode to specification:** Yes No N/A**Weld Procedures Followed:** Yes No N/A**Qualified Welders:** Yes No N/A**Verified Joint Fit-up:** Yes No N/A**Approved Drawings:** Yes No N/A**Approved WPS:** Yes No N/A**Delayed / Cancelled:** Yes No N/A**Bridge No:** 34-0006**Component:** OBG**Summary of Items Observed:**

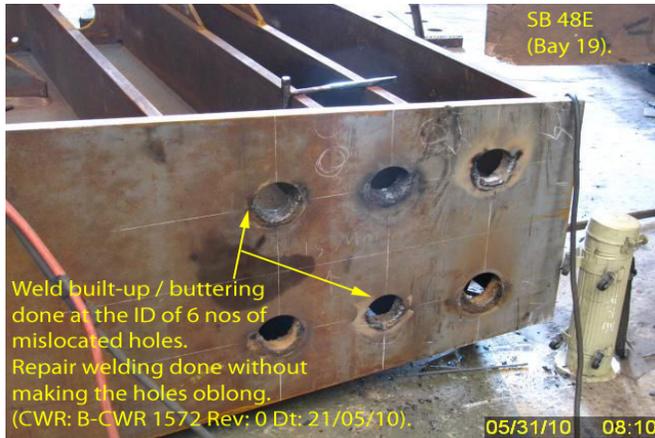
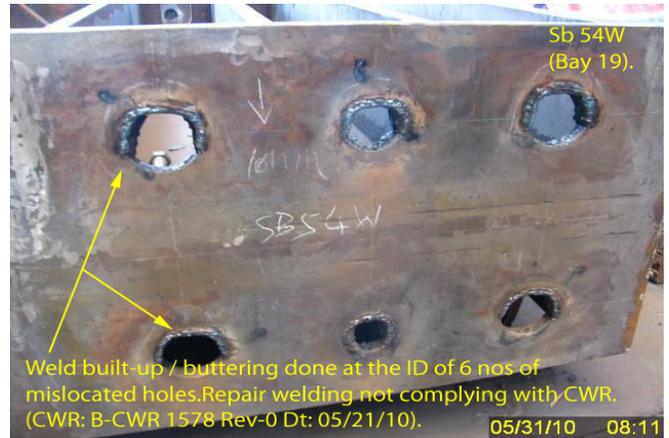
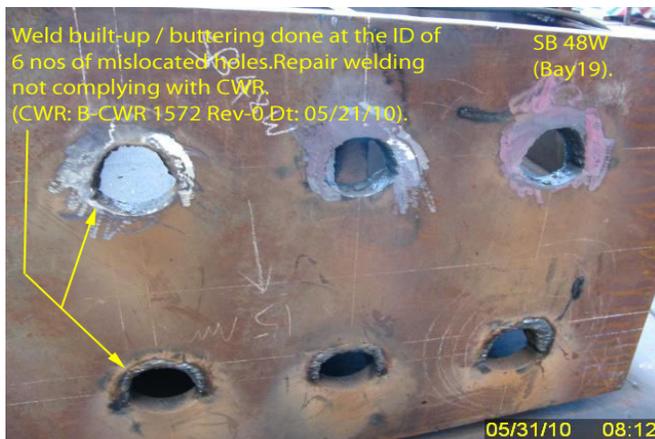
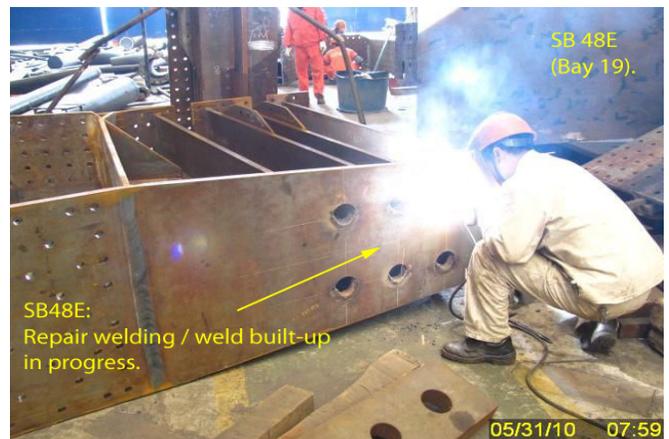
- ZPMC welding personnel performing base metal restoration of the mis-located suspender rod holes on suspender bracket identified as SB48E.
- The repairs did not appear to comply with the approved Critical Welding Report (CWR): B-CWR1572 and B-CWR1578.

- The above referenced CWR specifies elongating the holes by gouging, performing Magnetic particle Testing (MT) of the excavated area prior to welding and weld the hole longitudinally using stringer beads.

- ZPMC welder was observed buttering (build up with weld) the Inside Diameter (ID) of the mis-located holes. No elongation of the holes was performed prior to welding.

- This manner of repair appears to have been performed on all 6 suspender rod holes on the following suspender brackets: SB48E, SB48W & SB54W.
- This QA Inspector discussed this issue with ZPMC QC, Mr. Zhou Cheng that they did not appear to comply with the Contract documents and an incident report would be raised. ABF QA was identified as Mr. Zeng Wen Jun
