Contract #: 04-0120F4Cty: SF/ALA Rte: 80 PM: 13.2/13.9File #: 69.28**WELDING INSPECTION REPORT****Resident Engineer:** Pursell, Gary**Address:** 333 Burma Road**City:** Oakland, CA 94607**Report No:** WIR-014566**Date Inspected:** 07-Jun-2010**Project Name:** SAS Superstructure**OSM Arrival Time:** 700**Prime Contractor:** American Bridge/Fluor Enterprises, a JV**OSM Departure Time:** 1900**Contractor:** Zhenhua Port Machinery Company, Ltd (ZPMC), Changxing Island **Location:** Shanghai, China**CWI Name:** Li Yang**CWI Present:** Yes No**Inspected CWI report:** Yes No N/A**Rod Oven in Use:** Yes No N/A**Electrode to specification:** Yes No N/A**Weld Procedures Followed:** Yes No N/A**Qualified Welders:** Yes No N/A**Verified Joint Fit-up:** Yes No N/A**Approved Drawings:** Yes No N/A**Approved WPS:** Yes No N/A**Delayed / Cancelled:** Yes No N/A**Bridge No:** 34-0006**Component:** OBG**Summary of Items Observed:**

TRIAL ASSEMBLY YARD

OBG SEGMENT 8BW-8CW

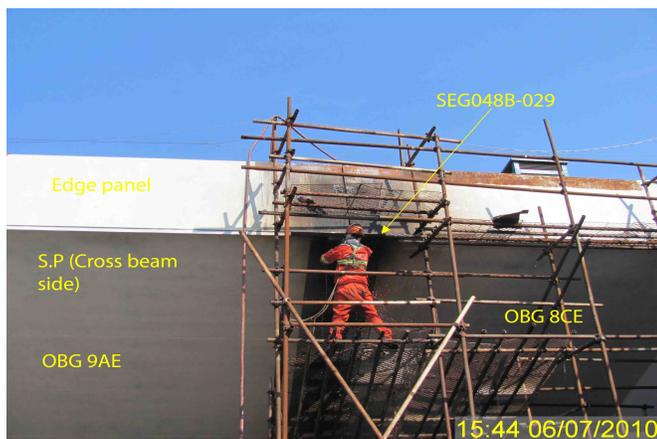
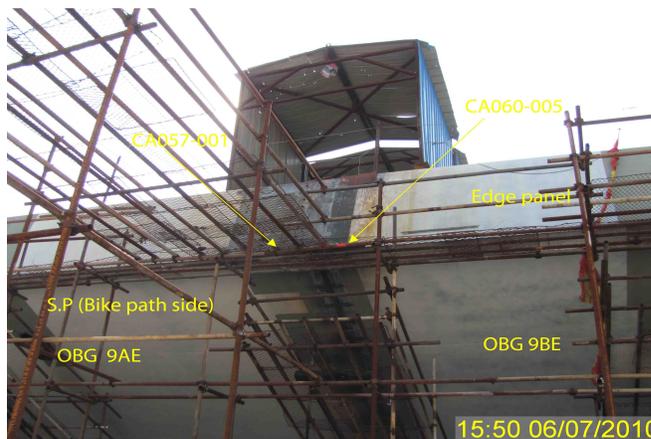
During the Ultrasonic Inspection this QA Inspector discovers three (3) transverse linear indications in the weld CA060-005, CA057-001, SEG048B-029. Incident report was issued.
