DEPARTMENT OF TRANSPORTATION

Contract #: 04-0120F4Cty: SF/ALA Rte: 80 PM: 13.2/13.9File #: 69.28**WELDING INSPECTION REPORT****Resident Engineer:** Pursell, Gary**Address:** 333 Burma Road**City:** Oakland, CA 94607**Report No:** WIR-014589**Date Inspected:** 24-May-2010**Project Name:** SAS Superstructure**OSM Arrival Time:** 700**Prime Contractor:** American Bridge/Fluor Enterprises, a JV**OSM Departure Time:** 1900**Contractor:** Zhenhua Port Machinery Company, Ltd (ZPMC), Changxing Island **Location:** Shanghai, China**CWI Name:** Zhu Feng**CWI Present:** Yes No**Inspected CWI report:** Yes No N/A**Rod Oven in Use:** Yes No N/A**Electrode to specification:** Yes No N/A**Weld Procedures Followed:** Yes No N/A**Qualified Welders:** Yes No N/A**Verified Joint Fit-up:** Yes No N/A**Approved Drawings:** Yes No N/A**Approved WPS:** Yes No N/A**Delayed / Cancelled:** Yes No N/A**Bridge No:** 34-0006**Component:** Tower Components**Summary of Items Observed:**

WELDING INSPECTION REPORT

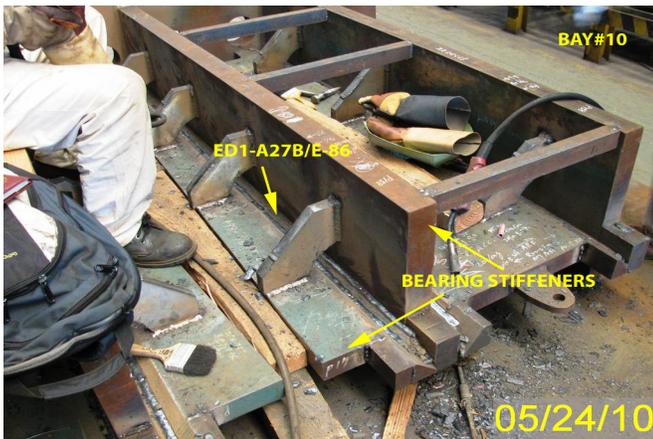
Weld joint # 86 located on Bearing Stiffener of Shear plate ED1 – A27B/E. Welder is identified as 040533. ZPMC Quality Control (QC) Inspector is identified as Lu Wei Chao. The welding variables recorded by QC appeared to comply with the WPS – B – T – 2331 – Tc – P4 – F.

(See attached photo)

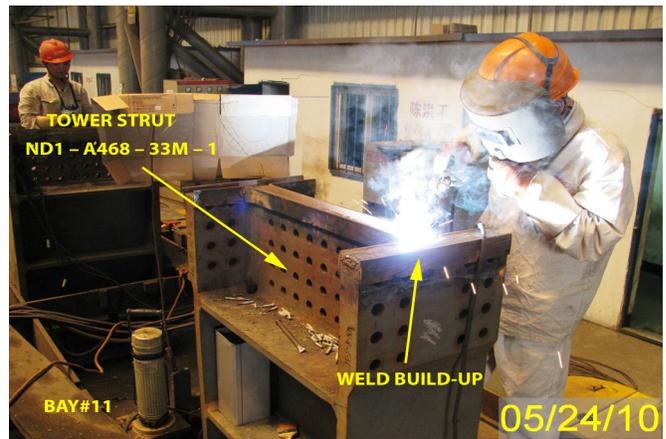
According to the Critical Weld Repair report T-CWR 628 weld build-up being performed on Tower Strut Plate ND1 – A468 – 33M – 1. Welder is identified as 202100. ZPMC Quality Control (QC) Inspector is identified as Shang Hai Long. The welding variables recorded by QC appeared to comply with the WPS – 485 – SMAW – 1G (1F) – Repair – 1. (See attached photo)
