**DEPARTMENT OF TRANSPORTATION**

Contract #: 04-0120F4Cty: SF/ALA Rte: 80 PM: 13.2/13.9File #: 69.28**WELDING INSPECTION REPORT****Resident Engineer:** Pursell, Gary**Address:** 333 Burma Road**City:** Oakland, CA 94607**Report No:** WIR-014591**Date Inspected:** 27-May-2010**Project Name:** SAS Superstructure**OSM Arrival Time:** 700**Prime Contractor:** American Bridge/Fluor Enterprises, a JV**OSM Departure Time:** 1900**Contractor:** Zhenhua Port Machinery Company, Ltd (ZPMC), Changxing Island **Location:** Shanghai, China**CWI Name:** Chen Shi Gang**CWI Present:** Yes No**Inspected CWI report:** Yes No N/A**Rod Oven in Use:** Yes No N/A**Electrode to specification:** Yes No N/A**Weld Procedures Followed:** Yes No N/A**Qualified Welders:** Yes No N/A**Verified Joint Fit-up:** Yes No N/A**Approved Drawings:** Yes No N/A**Approved WPS:** Yes No N/A**Delayed / Cancelled:** Yes No N/A**Bridge No:** 34-0006**Component:** OBG**Summary of Items Observed:**

OBG Bay 09, Deck Panel 13AE-DP3076-001

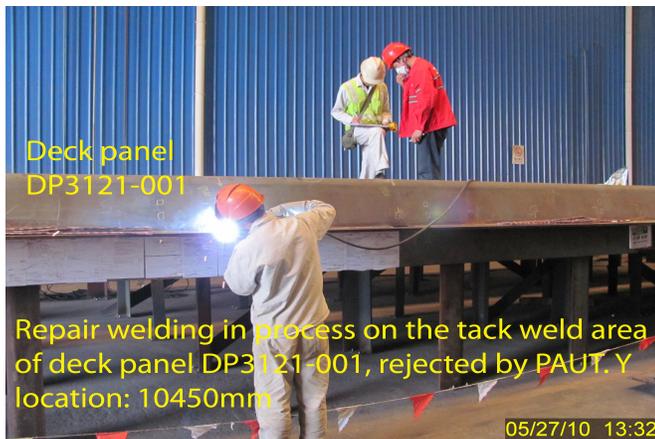
This QA inspector observed repair welding on the tack weld location of deck panel which were rejected by PAUT. Repair welding was being performed on deck panel DP3121-001. The weld procedure was found to be WPS-345-FCAW-2G(2F)-FCM-REPAIR. The welding operator was identified as 062259. The Y locations (in mm) were identified as follows:
