Contract #: 04-0120F4Cty: SF/ALA Rte: 80 PM: 13.2/13.9File #: 99.28**WELDING INSPECTION REPORT****Resident Engineer:** Pursell, Gary**Address:** 333 Burma Road**City:** Oakland, CA 94607**Report No:** WIR-014651**Date Inspected:** 10-Jun-2010**Project Name:** SAS Superstructure**OSM Arrival Time:** 700**Prime Contractor:** American Bridge/Fluor Enterprises, a JV**OSM Departure Time:** 1900**Contractor:** Zhenhua Port Machinery Company, Ltd (ZPMC) Chanxing Island**Location:** Shanghai, China

CWI Name:	N/A	CWI Present:	Yes	No
Inspected CWI report:	Yes No N/A	Rod Oven in Use:	Yes No N/A	
Electrode to specification:	Yes No N/A	Weld Procedures Followed:	Yes No N/A	
Qualified Welders:	Yes No N/A	Verified Joint Fit-up:	Yes No N/A	
Approved Drawings:	Yes No N/A	Approved WPS:	Yes No N/A	
		Delayed / Cancelled:	Yes No N/A	
Bridge No:	34-0006	Component:	OBG Segment 11DE

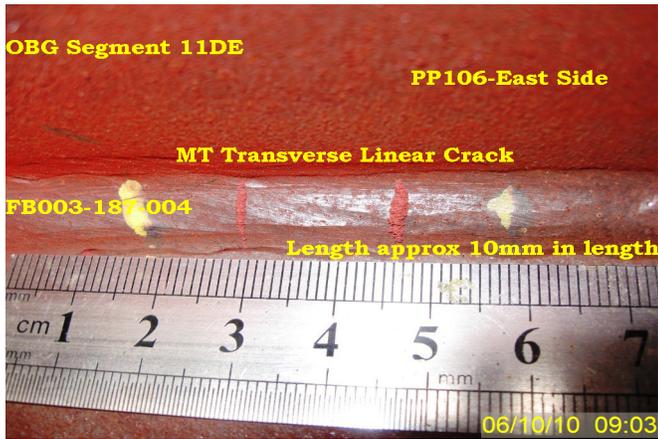
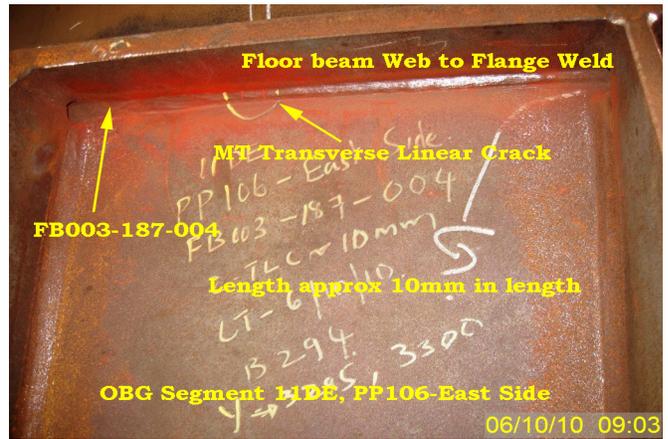
Description of Incident: During random Quality Assurance Visual review of welds located on segment 11DE, this Quality Assurance Inspector (QA) discovered three (3) Transverse linear indications measuring approximately 8 to 10mm in lengths. The indications were discovered visually and confirmed by Magnetic particle Testing (MT) by Caltrans QA. ZPMC Quality Control MT Technicians claimed that magnetic particle testing have been performed on these welds that require 25% MT. The indications are clearly marked on the material near the weld. The weld number is identified as FB003-187-004. The panel point is identified as a PP106. This weld is a Fillet weld joining the Floor beam Web to Flange. The Floor Beam Flange weld is identified as Non SPCM. For further information, please see the attached pictures
