Contract #: 04-0120F4Cty: SF/ALA Rte: 80 PM: 13.2/13.9File #: 1.28**WELDING INSPECTION REPORT****Resident Engineer:** Pursell, Gary**Address:** 333 Burma Road**City:** Oakland, CA 94607**Report No:** WIR-014666**Date Inspected:** 04-Jun-2010**Project Name:** SAS Superstructure**OSM Arrival Time:** 630**Prime Contractor:** American Bridge/Fluor Enterprises, a JV**OSM Departure Time:** 1500**Contractor:** American Bridge/Fluor Enterprises, a JV**Location:** Job Site

Bridge No: 34-0006**Component:** Orthotropic Box Girders**Summary of Items Observed:**

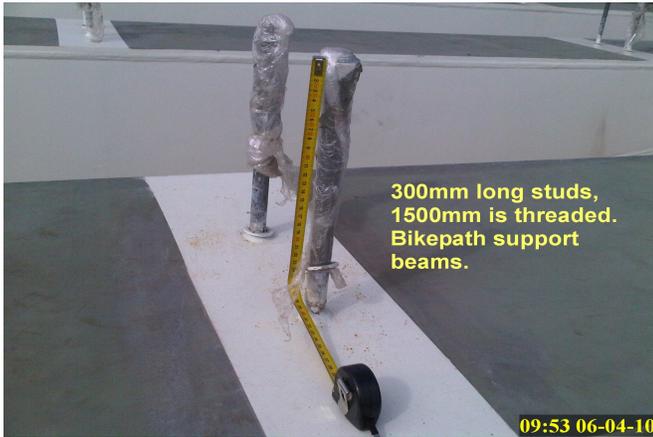
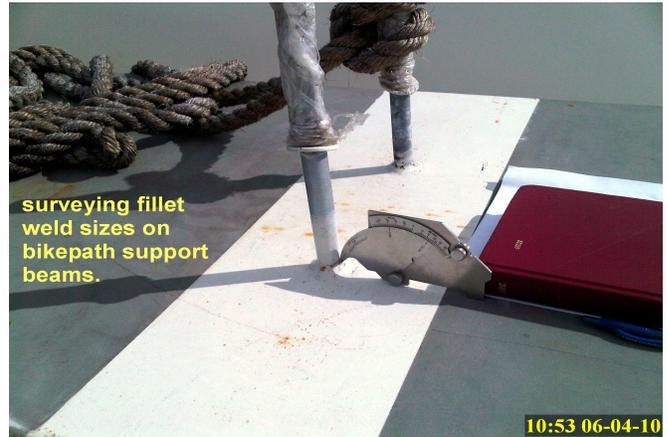
The QAI accompanied the Quality Control (QC) Inspector Mike Johnson and conducted a survey of the as received bike path support beams. The QAI was directed to measure the bike path panel mounting studs' fillet weld sizes, as they have been reported to be less than originally specified in the contract documents. The QAI and the QC Inspector conducted the survey on a total of 10 beams, 4 fillet welded studs on each beam (not previously checked by ABF). The QAI also reviewed the first 10 beams that were examined only by ABF's QC department. The QAI noted that 7 of the 10 beams' fillet weld sizes appeared to correspond with the information supplied by ABF, with the 3 remaining beams appearing to have less than reported fillet weld sizes. The QAI relayed these observations to the Lead QAI Bill Levell. The QAI was asked to generate a report document with the fillet weld sizes and locations. This work was in progress at the end of the shift.
