DEPARTMENT OF TRANSPORTATION

Contract #: 04-0120F4Cty: SF/ALA Rte: 80 PM: 13.2/13.9File #: 1.28**WELDING INSPECTION REPORT****Resident Engineer:** Pursell, Gary**Address:** 333 Burma Road**City:** Oakland, CA 94607**Report No:** WIR-014672**Date Inspected:** 09-Jun-2010**Project Name:** SAS Superstructure**OSM Arrival Time:** 730**Prime Contractor:** American Bridge/Fluor Enterprises, a JV**OSM Departure Time:** 1600**Contractor:** American Bridge/Fluor Enterprises, a JV**Location:** Job Site

Bridge No: 34-0006**Component:** Orthotropic Box Girders**Summary of Items Observed:**

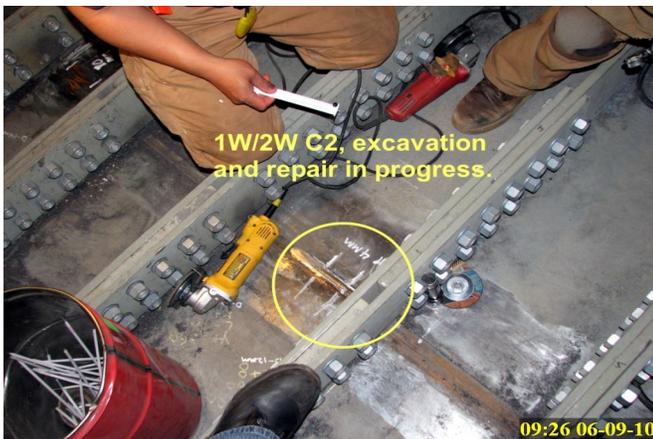
1) The QAI observed ABF personnel grinding and making first time repairs to the complete joint penetration (CJP) vertical (3G) butt weld on plate C, segments C1 and C2 in OBG lifts 1W/2W field splice. The QAI noted the repairs are being performed after ultrasonic testing (UT) has identified rejectable indications in the splice welds. The QAI noted that the Quality Control (QC) Inspector Bonifacio Daquinag is monitoring the excavating and welding of these repairs. The QAI observed ABF workers Chun Fai Tsui, ID 3426, and James Zhen, ID 6001, making the repair welds with shielded metal arc welding (SMAW) and 1/8" diameter E-7018H4R electrodes. The QAI was informed that welding procedure specification (WPS) ABF-WPS-D15-1001-Repair is being used for this welding. The QAI was informed that a total of 5 separate weld repairs will be made. See the attached photo.

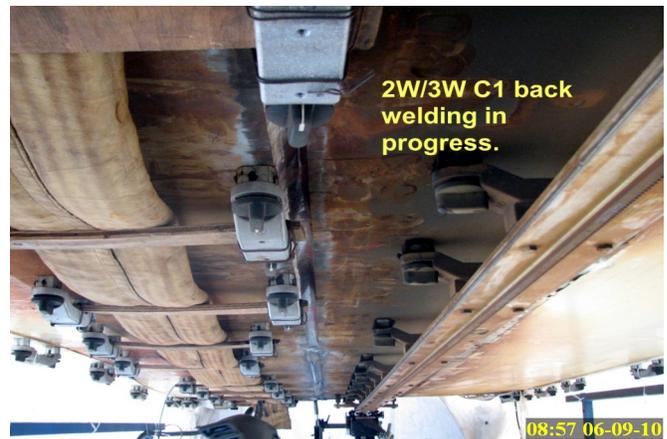
2) The QAI observed ABF personnel back welding plate C at OBG lifts 2W/3W field splice. The QAI noted that the overhead position (4G) CJP weld segments C1 and C2 are being completed after the backing bar has been removed. The QAI noted that the QC Inspector William Sherwood is monitoring this welding. The QAI observed

ABF workers Jeremy Dolman, ID 5042 and Rory Hogan, ID 3186, making the welds with gas shielded flux cored arc welding (FCAW-G). The QAI was informed that ABF-WPS-D15-3040A-1 is being used for this welding. The QAI randomly measured the preheat, interpass temperature and welding parameters and noted that they appeared to be conforming to the WPS requirements. See the attached photo.
