DEPARTMENT OF TRANSPORTATION

Quality Assurance and Source Inspection

Contract #: 04-0120F4Cty: SF/ALA Rte: 80 PM: 13.2/13.9File #: 1.28**WELDING INSPECTION REPORT****Resident Engineer:** Pursell, Gary**Address:** 333 Burma Road**City:** Oakland, CA 94607**Report No:** WIR-014677**Date Inspected:** 27-May-2010**Project Name:** SAS Superstructure**OSM Arrival Time:** 700**Prime Contractor:** American Bridge/Fluor Enterprises, a JV**OSM Departure Time:** 1530**Contractor:** American Bridge/Fluor Enterprises, a JV**Location:** Job Site**CWI Name:** See Below**CWI Present:** Yes No**Inspected CWI report:** Yes No N/A**Rod Oven in Use:** Yes No N/A**Electrode to specification:** Yes No N/A**Weld Procedures Followed:** Yes No N/A**Qualified Welders:** Yes No N/A**Verified Joint Fit-up:** Yes No N/A**Approved Drawings:** Yes No N/A**Approved WPS:** Yes No N/A**Delayed / Cancelled:** Yes No N/A**Bridge No:** 34-0006**Component:** Orthotropic Box Girders (OBG)**Summary of Items Observed:**

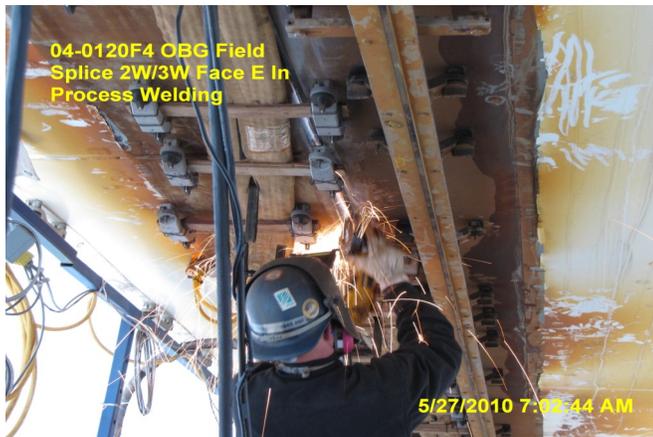
Field Splice 2W/3W Face E (Outside)

The QA inspector periodically observed the in process Flux Cored Arc Welding (FCAW-G) being performed in the 4G overhead position by ABF welding personnel Jeremy Dolan for the balance of the weld joint. QC inspector Jim Cunningham was noted to be present in order to monitor the progress and ensure the welding was within the established Welding Procedure Specification (WPS) noted as ABF-WPS-D1.5-3040A-4. The preheat and interpass temperature was verified by the QC and QA inspector to be greater than 65° Celsius (C) and the parameters were verified to be 233 amps, 23.4 volts and a measured travel speed of 153mm/min. The welder is in the process of placing the final cover pass at this time. The work was completed later in the shift with grinding and blending following and the work appeared to be in general compliance with the contract documents. A digital photo is included in the body of this report for general information.
