DEPARTMENT OF TRANSPORTATION

Contract #: 04-0120F4Cty: SF/ALA Rte: 80 PM: 13.2/13.9File #: 1.28**WELDING INSPECTION REPORT****Resident Engineer:** Pursell, Gary**Address:** 333 Burma Road**City:** Oakland, CA 94607**Report No:** WIR-014680**Date Inspected:** 11-Jun-2010**Project Name:** SAS Superstructure**OSM Arrival Time:** 1100**Prime Contractor:** American Bridge/Fluor Enterprises, a JV**OSM Departure Time:** 1930**Contractor:** American Bridge/Fluor Enterprises, a JV**Location:** Job Site**CWI Name:** See Below**CWI Present:** Yes No**Inspected CWI report:** Yes No N/A**Rod Oven in Use:** Yes No N/A**Electrode to specification:** Yes No N/A**Weld Procedures Followed:** Yes No N/A**Qualified Welders:** Yes No N/A**Verified Joint Fit-up:** Yes No N/A**Approved Drawings:** Yes No N/A**Approved WPS:** Yes No N/A**Delayed / Cancelled:** Yes No N/A**Bridge No:** 34-0006**Component:** Orthotropic Box Girders**Summary of Items Observed:**

WELDING INSPECTION REPORT

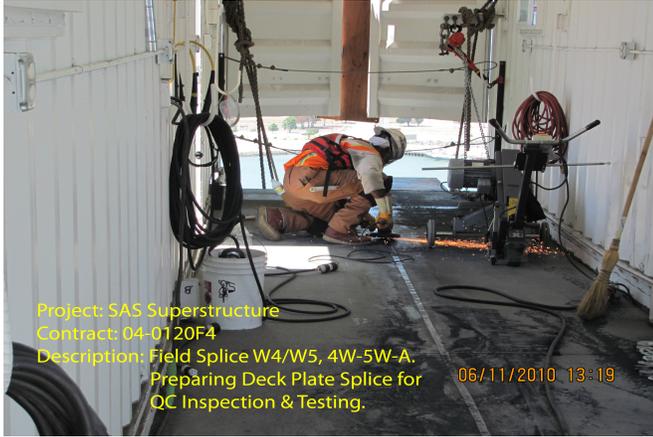
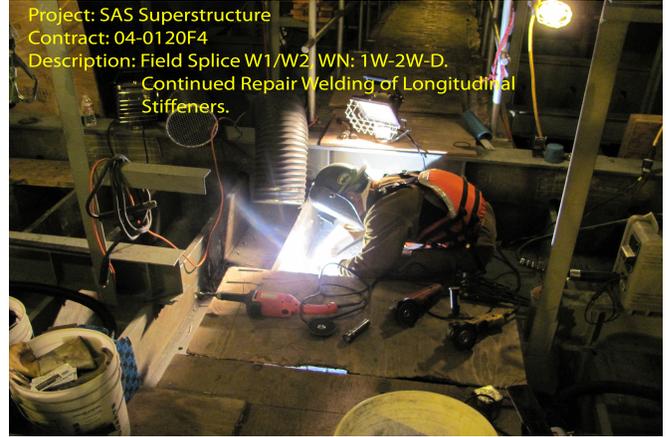
The QAI observed Chun Fai Tsui ID-3426 perform the repair welding of the areas marked as UT rejects on the longitudinal stiffener Complete Joint Penetration (CJP) groove welds identified as WN: 1W-2W-D-S5 and S8. Also at the conclusion of the excavations the QC technician Jesse Cayabyab performed a Magnetic Particle Test (MPT) of the excavated areas and no rejectable indications were noted. The application and evaluation of the MPT appeared to comply with the MPT procedure identified as SE-MT-CT-D1.5-101 Rev. 4. The repair welding was performed utilizing the Shielded Metal Arc Welding (SMAW) process and 3.2mm electrode as per the Welding Procedure Specification (WPS) identified as ABF-WPS-1000 Repair Rev. 1. The WPS was also used by the QC inspector, Mr. Cayabyab as a reference to monitor and verify the Direct Current welding parameters and were noted as 127 amps. The welding was performed in the vertical position (3G) with the work positioned approximately in the vertical plane with the groove approximately vertical and the weld progression up.

The QAI observed the machining of the weld profile on the deck plate field splice identified as WN: 4W-5W-A. The machining of the weld surface was performed utilizing a semi-automatic surface grinder and is being performed for the preparation of QC inspection and testing.

The digital photographs on page 3 of this report illustrate the work observed during this scheduled shift.
