DEPARTMENT OF TRANSPORTATION

Quality Assurance and Source Inspection

Contract #: 04-0120F4Cty: SF/ALA Rte: 80 PM: 13.2/13.9File #: 1.28**WELDING INSPECTION REPORT****Resident Engineer:** Pursell, Gary**Address:** 333 Burma Road**City:** Oakland, CA 94607**Report No:** WIR-014692**Date Inspected:** 07-Jun-2010**Project Name:** SAS Superstructure**OSM Arrival Time:** 1100**Prime Contractor:** American Bridge/Fluor Enterprises, a JV**OSM Departure Time:** 1930**Contractor:** American Bridge/Fluor Enterprises, a JV**Location:** Job Site**CWI Name:** See Below**CWI Present:** Yes No**Inspected CWI report:** Yes No N/A**Rod Oven in Use:** Yes No N/A**Electrode to specification:** Yes No N/A**Weld Procedures Followed:** Yes No N/A**Qualified Welders:** Yes No N/A**Verified Joint Fit-up:** Yes No N/A**Approved Drawings:** Yes No N/A**Approved WPS:** Yes No N/A**Delayed / Cancelled:** Yes No N/A**Bridge No:** 34-0006**Component:** Orthotropic Box Girders**Summary of Items Observed:**

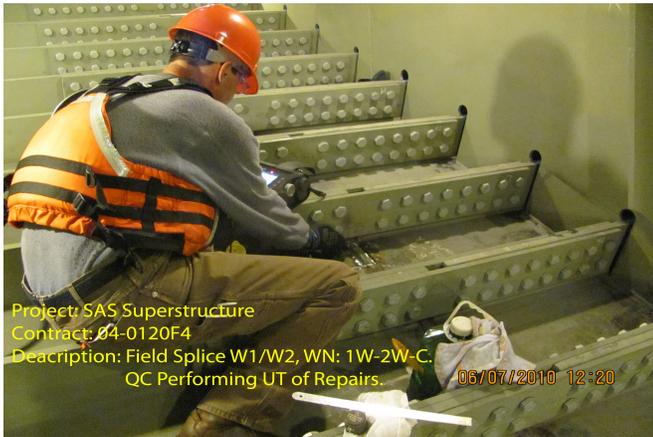
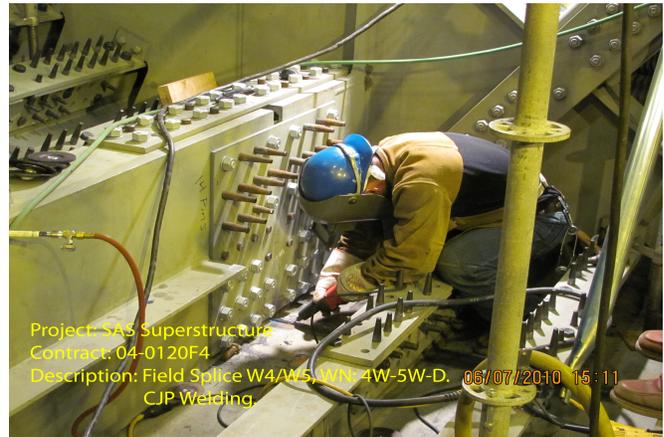
The digital photographs below illustrate the work observed during this scheduled shift.
