Contract #: 04-0120F4Cty: SF/ALA Rte: 80 PM: 13.2/13.9File #: 1.28**WELDING INSPECTION REPORT****Resident Engineer:** Pursell, Gary**Address:** 333 Burma Road**City:** Oakland, CA 94607**Report No:** WIR-014695**Date Inspected:** 08-Jun-2010**Project Name:** SAS Superstructure**OSM Arrival Time:** 1100**Prime Contractor:** American Bridge/Fluor Enterprises, a JV**OSM Departure Time:** 1930**Contractor:** American Bridge/Fluor Enterprises, a JV**Location:** Job Site**CWI Name:** See Below**CWI Present:** Yes No**Inspected CWI report:** Yes No N/A**Rod Oven in Use:** Yes No N/A**Electrode to specification:** Yes No N/A**Weld Procedures Followed:** Yes No N/A**Qualified Welders:** Yes No N/A**Verified Joint Fit-up:** Yes No N/A**Approved Drawings:** Yes No N/A**Approved WPS:** Yes No N/A**Delayed / Cancelled:** Yes No N/A**Bridge No:** 34-0006**Component:** Orthotropic Box Girders**Summary of Items Observed:**

WELDING INSPECTION REPORT

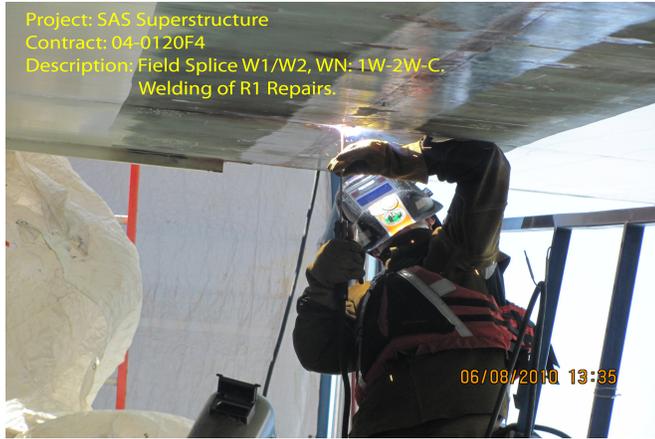
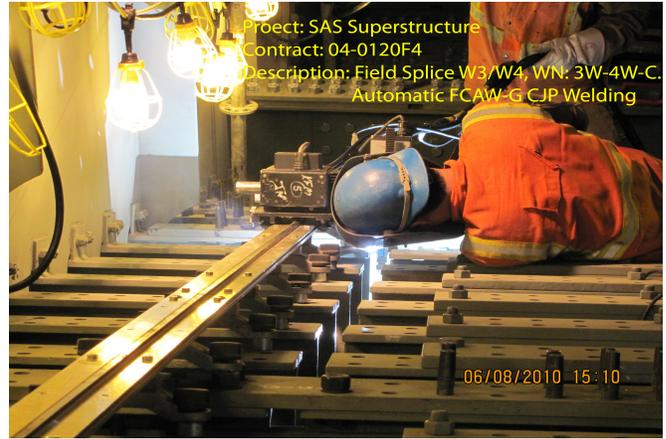
The digital photographs on page 3 of this report illustrate the work observed during this scheduled shift.
