**DEPARTMENT OF TRANSPORTATION**

Contract #: 04-0120F4Cty: SF/ALA Rte: 80 PM: 13.2/13.9File #: 1.28**WELDING INSPECTION REPORT****Resident Engineer:** Pursell, Gary**Address:** 333 Burma Road**City:** Oakland, CA 94607**Report No:** WIR-014696**Date Inspected:** 08-Jun-2010**Project Name:** SAS Superstructure**OSM Arrival Time:** 630**Prime Contractor:** American Bridge/Fluor Enterprises, a JV**OSM Departure Time:** 1500**Contractor:** American Bridge/Fluor Enterprises, a JV**Location:** Job Site

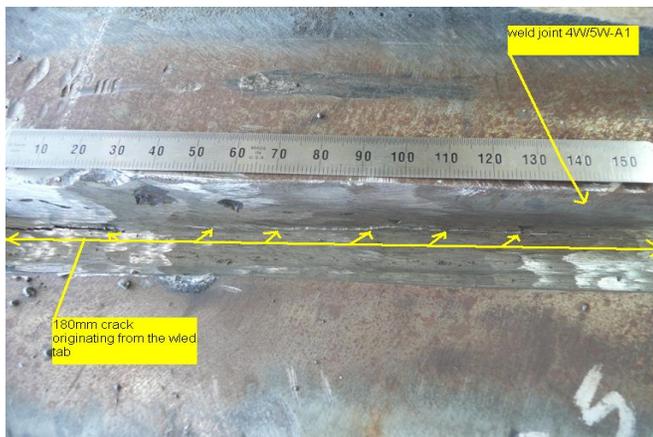
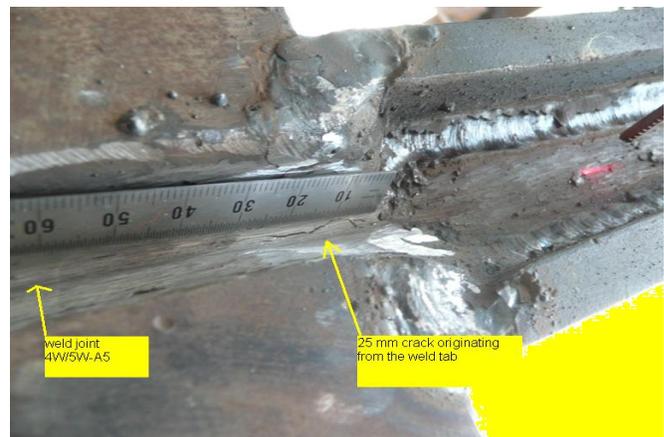
## 4W/5W-A

The QA Inspector randomly observed the ABF welding personnel setting up the submerged arc welding equipment and induction preheating equipment to begin the SAW on the above identified weld joint. The QA Inspector randomly observed the material to be welded was approximately 150°F at the time of the QA Inspectors arrival. It was noted no SAW had been started at the time of the QA Inspectors arrival at the above identified location. Upon the arrival the QA Inspector observed two cracks on opposite ends of the weld joint in the shielded metal arc welding (SMAW) full length tack welds. The first crack observed was in the weld segment identified as A1. The QA Inspector performed measurements of the crack and noted it appeared to be 180mm in length and originating at the weld tab and propagating 180mm into the weld joint. The QA Inspector noted the crack was propagating in the SMAW full length tack weld joining the steel backing bar to the bevel face of the OBG identified as 5W. The QA Inspector noted the 180mm crack measured by the QA Inspector was only observed by visual testing (VT) and the extent of the crack was not determined with any NDT method by the QA Inspector. In addition another crack was located by the QA Inspector in the weld segment identified as A5. The QA Inspector performed measurements of the crack and noted it appeared to be 25mm in length and originating at the weld tab and propagating 25mm into the weld joint. The QA Inspector noted the crack was propagating in the SMAW full length tack weld joining the steel backing bar to the bevel face of the OBG identified as 5W. The QA Inspector noted the 25mm crack measured by the QA Inspector was only observed by VT only and the extent of the crack was not determined with any NDT method by the QA Inspector. The QA Inspector informed the Smith Emery (SE) Quality Control Inspector Steve McConnell of the cracks located by the QA Inspector. In addition the QA Inspector informed the ABF Welding Superintendent Dan Ieraci and the QA Inspector Mike Foerder of the issue identified above. At 1200 the QA Inspector turned over with the QA Inspector Danny Reyes and Mr. Reyes observed the repairs of the cracked areas for the remainder of the shift.

At 1200 the QA Inspector Mike Foerder informed the QA Inspector Rick Bettencourt ABF had a verbal approval per Senior Task Lead Patrick Lowry to excavate the cracked areas in weld segment 4W/5W-A1/A5.
