**DEPARTMENT OF TRANSPORTATION**

Contract #: 04-0120F4Cty: SF/ALA Rte: 80 PM: 13.2/13.9File #: 1.28**WELDING INSPECTION REPORT****Resident Engineer:** Pursell, Gary**Address:** 333 Burma Road**City:** Oakland, CA 94607**Report No:** WIR-014697**Date Inspected:** 09-Jun-2010**Project Name:** SAS Superstructure**OSM Arrival Time:** 630**Prime Contractor:** American Bridge/Fluor Enterprises, a JV**OSM Departure Time:** 1500**Contractor:** American Bridge/Fluor Enterprises, a JV**Location:** Job Site

## WELDING INSPECTION REPORT

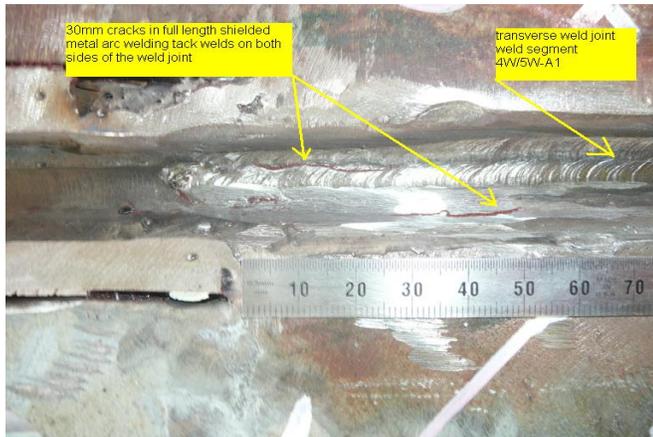
Upon the arrival of the QA Inspector a 33mm crack was observed in the full length shielded metal arc welding (SMAW) tack weld in the weld segment identified as A1. The crack was located in the SMAW tack weld attaching the steel backing bar to the bevel face of the OBG 4W. It was noted by the QA Inspector the Smith Emery Quality Control (QC) Inspector Steve McConnell had already performed magnetic particle testing of the area. On the previous day shift a 180mm crack was located, excavated and re-welded on in the same weld segment originating from the weld tab but on the opposite side of the weld joint. The previous crack was located in the SMAW tack weld attaching the steel backing to the OBG 5W bevel face. Upon the QA Inspectors discovery of the 33mm crack, the QC Inspector approached the QA Inspector in frustration (see summary of conversations). The QA Inspector noted the SE Lead QC Inspector Leonard Cross was present at the time of the conversation.

Within 30 minutes of the discovery of the above identified crack an additional crack was located opposite the 33mm crack in the full length SMAW tack weld against the bevel of the OBG 5W. The second crack was located in the full length SMAW tack weld against the bevel of the OBG 4W. The QA Inspector noted the additional crack measured approximately 30mm in length and also originated from the weld tab (both cracks pictured below). The QA Inspector informed the QA Inspector Mike Foerder of the cracks and Mr. Foerder was speaking directly with the Welding Quality Control Manager (WQCM) Jim Bowers on getting the repair procedure approved at 0800.

At approximately 0815 the QA Inspector randomly observed the ABF Welding Superintendent Dan Ieraci performed minimal grinding of the two cracked areas and immediately instructed the ABF welder Kenny Chappell to perform SMAW root and fill passes. The QA Inspector noted the ABF welder began performing the SMAW fill passes of the cracked areas, which appeared to be welding over the cracks. The QA Inspector noted the SE QC Inspectors Steve McConnell, Leonard Cross and the QA Inspector were standing by to perform MT of the areas to determine the extent of the cracks. The QA Inspector noted no access was granted by the Welding Superintendent and the ABF welder proceeded to perform SMAW of the cracked area. The QA Inspector immediately asked the Welding Superintendent why no MT was performed of the areas prior to welding (see summary of conversation).

The QA Inspector noted the ABF welding personnel proceeded with production welding including the repairs of the cracked area with out prior written permission or approval from the engineer. The QA Inspector wrote and submitted to Incident Reports for the issues described above. The first Incident Report was written for the contractor proceeding with the repair with out acquiring prior written permission or approval by the engineer, which is a direct non conformance of the Caltrans Special Provisions. The second Incident Report was written for the contractor not affording the QC Inspector access to perform MT of the excavated area to determine the extent of the cracking and not verifying the crack had been completely removed and the excavation was extended 50mm beyond.
