**DEPARTMENT OF TRANSPORTATION**

Contract #: 04-0120F4Cty: SF/ALA Rte: 80 PM: 13.2/13.9File #: 1.28**WELDING INSPECTION REPORT****Resident Engineer:** Pursell, Gary**Address:** 333 Burma Road**City:** Oakland, CA 94607**Report No:** WIR-014780**Date Inspected:** 15-Jun-2010**Project Name:** SAS Superstructure**OSM Arrival Time:** 1100**Prime Contractor:** American Bridge/Fluor Enterprises, a JV**OSM Departure Time:** 1930**Contractor:** American Bridge/Fluor Enterprises, a JV**Location:** Job Site**CWI Name:** See Below**CWI Present:** Yes No**Inspected CWI report:** Yes No N/A**Rod Oven in Use:** Yes No N/A**Electrode to specification:** Yes No N/A**Weld Procedures Followed:** Yes No N/A**Qualified Welders:** Yes No N/A**Verified Joint Fit-up:** Yes No N/A**Approved Drawings:** Yes No N/A**Approved WPS:** Yes No N/A**Delayed / Cancelled:** Yes No N/A**Bridge No:** 34-0006**Component:** Orthotropic Box Girders**Summary of Items Observed:**

## WELDING INSPECTION REPORT

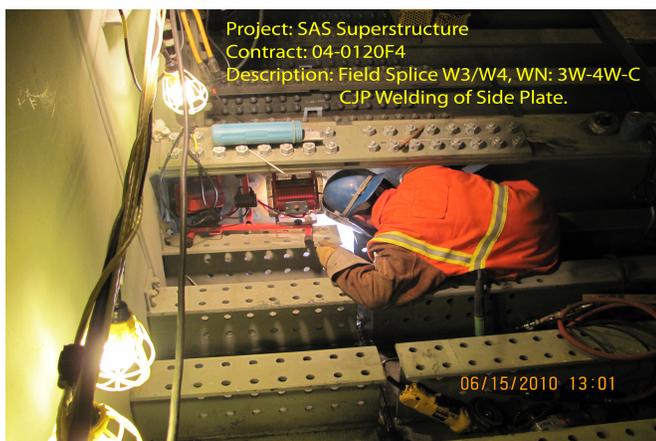
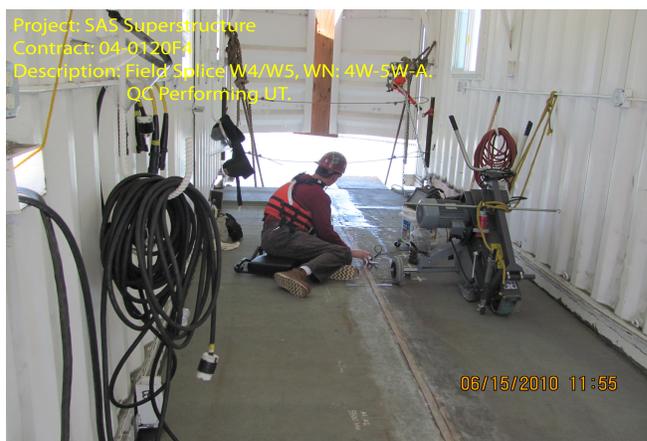
The digital photographs, below, illustrate the work observed during this scheduled shift.
