Contract #: 04-0120F4Cty: SF/ALA Rte: 80 PM: 13.2/13.9File #: 13.28**WELDING INSPECTION REPORT****Resident Engineer:** Pursell, Gary**Address:** 333 Burma Road**City:** Oakland, CA 94607**Report No:** WIR-014801**Date Inspected:** 15-Jun-2010**Project Name:** SAS Superstructure**OSM Arrival Time:** 1000**Prime Contractor:** American Bridge/Fluor Enterprises, a JV**OSM Departure Time:** 1830**Contractor:** Oregon Iron Works Clackamas, Or.**Location:** Clackamas, OR

**Bridge No:** 34-0006**Component:** Hinge K Pipe Beams**Summary of Items Observed:**

**Hinge-K Pipe Beam Assembly 101A-3:**

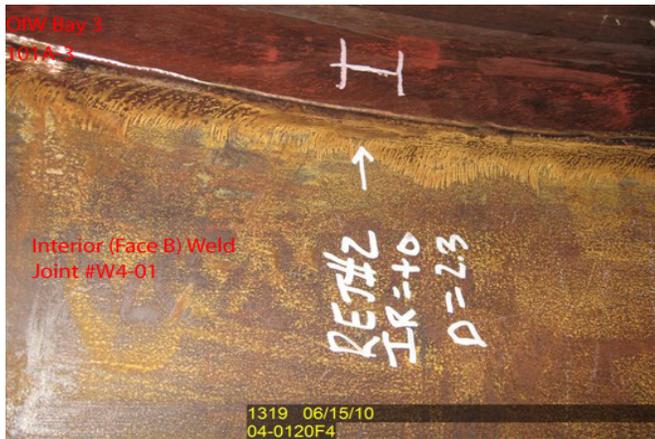
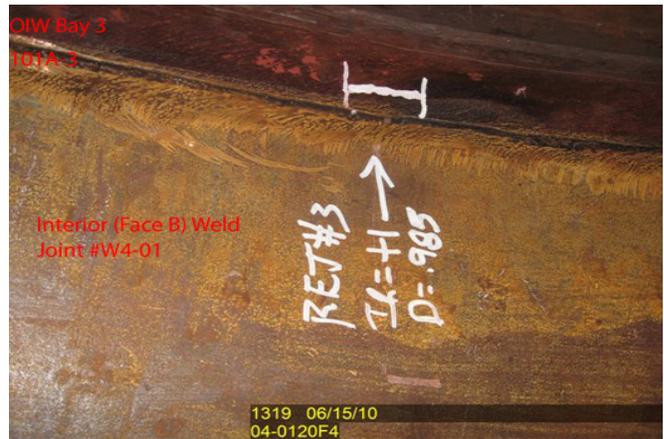
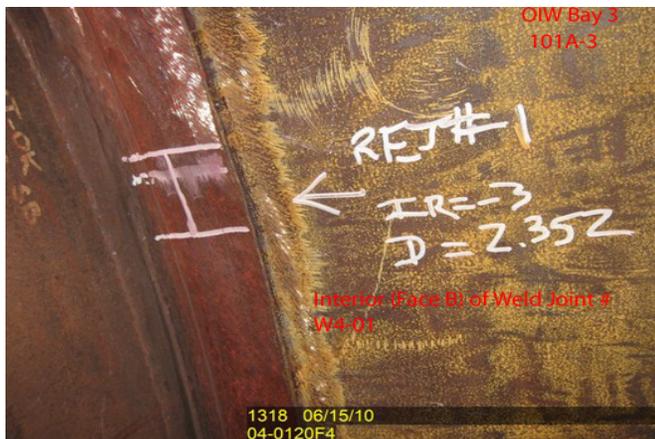
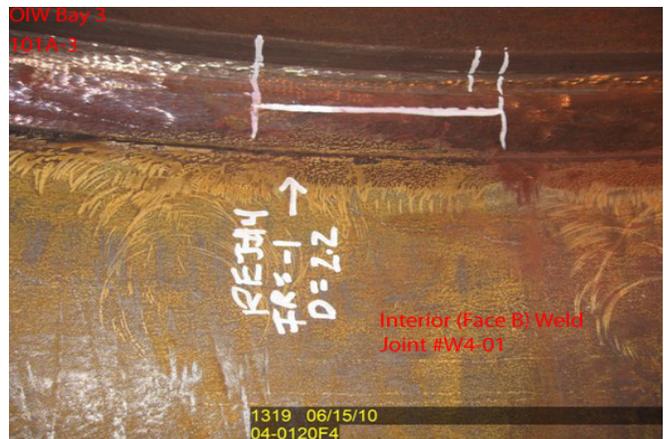
The QA Inspector observed OIW Lead QC Inspector Mike Gregson performing Ultrasonic Testing on the Weld Joint #W4-01. The QA Inspector noted that this Complete Joint Penetration (AWS D1.5 B-U7-S), was the Fuse 120A-3 to Forging 102A-3 and that QC Inspector Gregson was performing the testing from the interior or Face "B" side of the joint. The QA Inspector observed that QC Inspector Gregson was utilizing a 70 degree Lucite wedge testing angle attached to a 2.25 MHz transducer and the testing was being performed from both sides of the weld axis.

The QA Inspector was later informed by QC Inspector Gregson that he had completed the testing on Face "B" at the end of the shift and a total of 4 rejectable indications were found. QC Inspector Gregson explained that he had recently completed a preliminary testing report and provided the QA Inspector with a photocopy.

The QA Inspector reviewed the testing report and per the testing report, the rejectable indications which were found by QC Inspector Gregson, were rated as Class A discontinuities, per AWS D1.5 UT Acceptance-Rejection

Criteria-Tensile Stress, Table 6.3. Per the testing report the indications were rated at -3 db, -1db, +0 db and +1 db and had various depths of 25 mm-58 mm, as measured from the testing side of the weld axis, or Face B. Per the testing, the indications had varying lengths of 38 mm-171 mm.

QC Inspector Gregson then informed the QA Inspector that he had marked the areas for weld repairs from the interior side or Face B. QC Inspector Gregson explained that due to the depths of the defects that three of the four areas will have to excavated from the exterior or Face B side of the weld joint, to be classified as non-critical weld repairs. The QA Inspector noted that per AWS D1.5, "The depth of groove weld excavations shall not exceed 65 percent of the weld size shown on the drawing", to be classified as a non-critical weld repair.

QC Inspector Gregson explained that production will transfer the areas marked for repairs, to the appropriate side of the weld joint, where the excavations will be performed from. See attached pictures below.
