Quality Assurance and Source Inspection

Contract #: 04-0120F4Cty: SF/ALA Rte: 80 PM: 13.2/13.9File #: 69.28**WELDING INSPECTION REPORT****Resident Engineer:** Pursell, Gary**Address:** 333 Burma Road**City:** Oakland, CA 94607**Report No:** WIR-014850**Date Inspected:** 16-May-2010**Project Name:** SAS Superstructure**OSM Arrival Time:** 1900**Prime Contractor:** American Bridge/Fluor Enterprises, a JV**OSM Departure Time:** 700**Contractor:** Zhenhua Port Machinery Company, Ltd (ZPMC), Changxing Island **Location:** Shanghai, China**CWI Name:** See Below**CWI Present:** Yes No**Inspected CWI report:** Yes No N/A**Rod Oven in Use:** Yes No N/A**Electrode to specification:** Yes No N/A**Weld Procedures Followed:** Yes No N/A**Qualified Welders:** Yes No N/A**Verified Joint Fit-up:** Yes No N/A**Approved Drawings:** Yes No N/A**Approved WPS:** Yes No N/A**Delayed / Cancelled:** Yes No N/A**Bridge No:** 34-0006**Component:** OBG and Tower**Summary of Items Observed:**

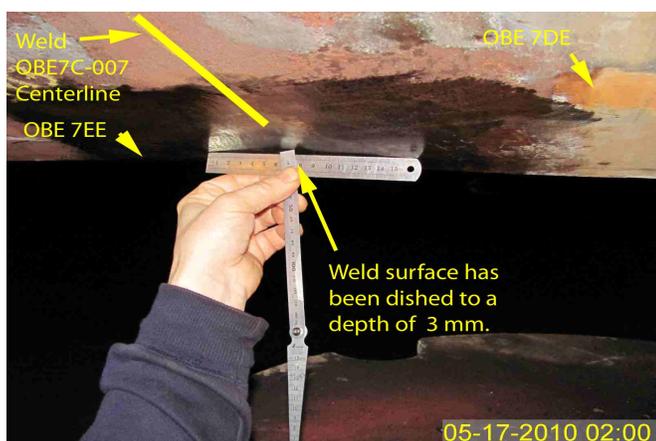
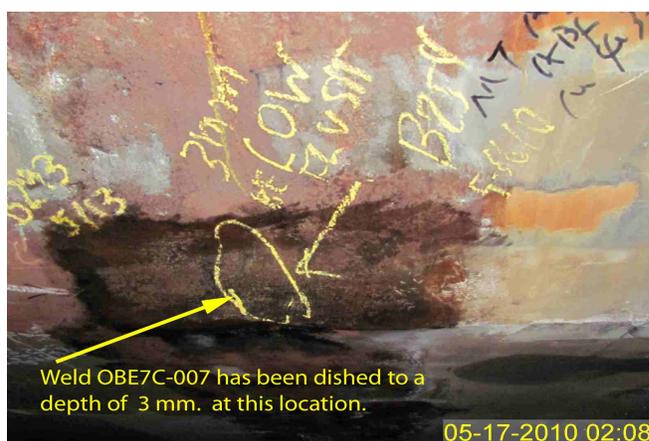
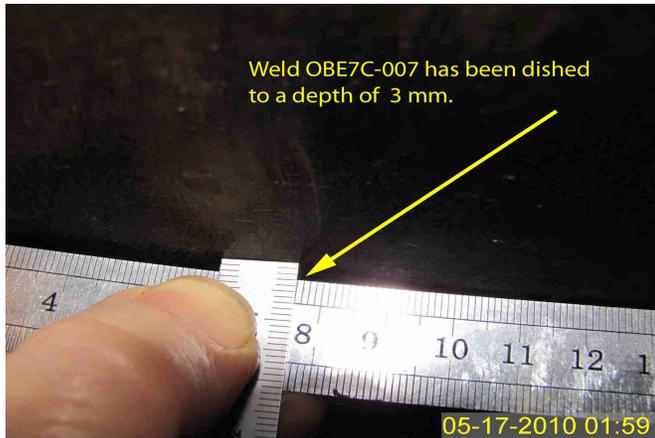
Blast Shop #1

This QA Inspector along with Caltrans QA Inspectors Mr. Mike Hasler, Mr. Daniel Barrentine and Mr. George Goulet performed random visual inspections of North tower lift 1 elevations 0 to 16.5 meters. ZPMC has recently completed initial grit blasting, prior to application of paint, and the steel surfaces that were inspected were mostly free of rust oxide and other contaminants that had previously obscured portions of the plates and weld surfaces. ABF and ZPMC Inspectors performed a cursory inspection of the areas indicated above and this QA Inspector visually observed approximately 50 locations that required grinding to resolve visual weld spatter, arc strikes, shallow nicks, scrapes, and other minor surface rejections. The areas that require rework were marked with colored chalk and ZPMC workers were using electric grinders to remove the visually unacceptable areas and ZPMC will be performing magnetic particle inspections of the arc strike removal areas after they are removed.
