DEPARTMENT OF TRANSPORTATION

Contract #: 04-0120F4Cty: SF/ALA Rte: 80 PM: 13.2/13.9File #: 69.28**WELDING INSPECTION REPORT****Resident Engineer:** Pursell, Gary**Address:** 333 Burma Road**City:** Oakland, CA 94607**Report No:** WIR-014864**Date Inspected:** 30-May-2010**Project Name:** SAS Superstructure**OSM Arrival Time:** 1900**Prime Contractor:** American Bridge/Fluor Enterprises, a JV**OSM Departure Time:** 700**Contractor:** Zhenhua Port Machinery Company, Ltd (ZPMC), Changxing Island **Location:** Shanghai, China**CWI Name:** See Below**CWI Present:** Yes No**Inspected CWI report:** Yes No N/A**Rod Oven in Use:** Yes No N/A**Electrode to specification:** Yes No N/A**Weld Procedures Followed:** Yes No N/A**Qualified Welders:** Yes No N/A**Verified Joint Fit-up:** Yes No N/A**Approved Drawings:** Yes No N/A**Approved WPS:** Yes No N/A**Delayed / Cancelled:** Yes No N/A**Bridge No:** 34-0006**Component:** OBG & Tower**Summary of Items Observed:**

OBG Bay 2

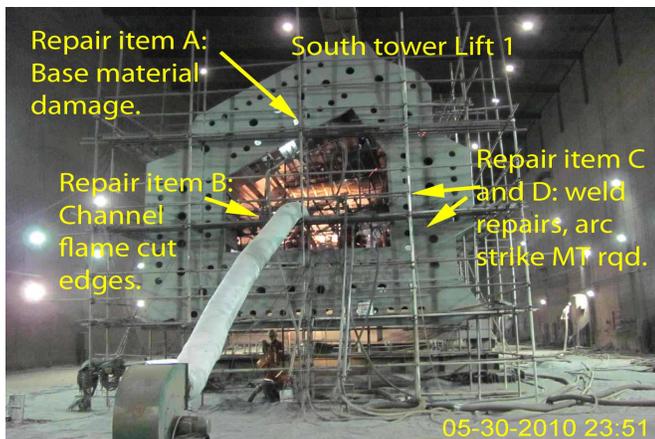
ZPMC requested Caltrans personnel to perform visual inspections of South Tower Lift 1 from 0 meters to 9 meters at around 2030 hours following the initial blast cleaning of the steel surfaces. Caltrans QA Inspectors George Goulet and Paul Dawson performed random visual inspections of these areas. ABF and ZPMC Inspectors performed visual inspections of the areas indicated above and this QA Inspector visually observed several areas that have light areas of rust which indicates the grit blasting was not adequate to prepare the metal surfaces prior to application of paint and approximately 50 locations that required grinding to resolve visual weld spatter, arc strikes, shallow nicks, scrapes, and other minor surface rejections. Approximately 4 locations were marked by ZPMC QC, ABF and/or Caltrans Inspectors as needing to be weld repaired. These weld repair areas have been covered by black electrical or similar tape. See the photograph below for additional information.

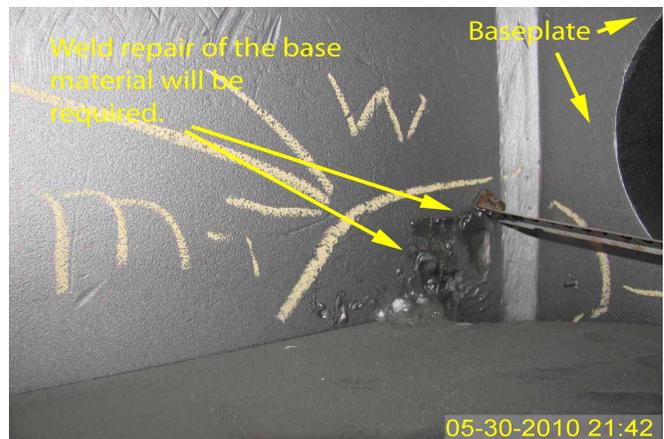
Repair Item A: One of the upper stiffeners on the inside of the baseplate appears to have severe base material

damage in a 50mm by 75mm area and it appears to be in need of a weld repair. We do not have a drawing that shows the stiffener plate locations and this stiffener plate does not have an identification number, but it is near the center of skin plate E, on the upper portion of the steel. The area has now been taped over pending repairs. See the photograph below for additional information.

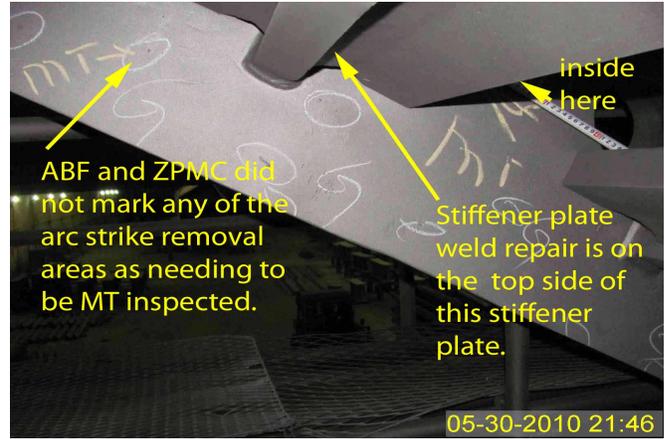
Repair Item D: ZPMC and ABF identified several arc strikes as needing to be removed and none of these areas were marked by these Inspectors as needing to be MT inspected. QA marked several of these areas as needing MT inspections. See the photograph below for additional information.
