Contract #: 04-0120F4Cty: SF/ALA Rte: 80 PM: 13.2/13.9File #: 69.28**WELDING INSPECTION REPORT****Resident Engineer:** Pursell, Gary**Address:** 333 Burma Road**City:** Oakland, CA 94607**Report No:** WIR-014874**Date Inspected:** 13-Jun-2010**Project Name:** SAS Superstructure**OSM Arrival Time:** 1900**Prime Contractor:** American Bridge/Fluor Enterprises, a JV**OSM Departure Time:** 700**Contractor:** Zhenhua Port Machinery Company, Ltd (ZPMC), Changxing Island **Location:** Shanghai, China**CWI Name:** See Below**CWI Present:** Yes No**Inspected CWI report:** Yes No N/A**Rod Oven in Use:** Yes No N/A**Electrode to specification:** Yes No N/A**Weld Procedures Followed:** Yes No N/A**Qualified Welders:** Yes No N/A**Verified Joint Fit-up:** Yes No N/A**Approved Drawings:** Yes No N/A**Approved WPS:** Yes No N/A**Delayed / Cancelled:** Yes No N/A**Bridge No:** 34-0006**Component:** OBG**Summary of Items Observed:**

OBG Segment Trial Assembly

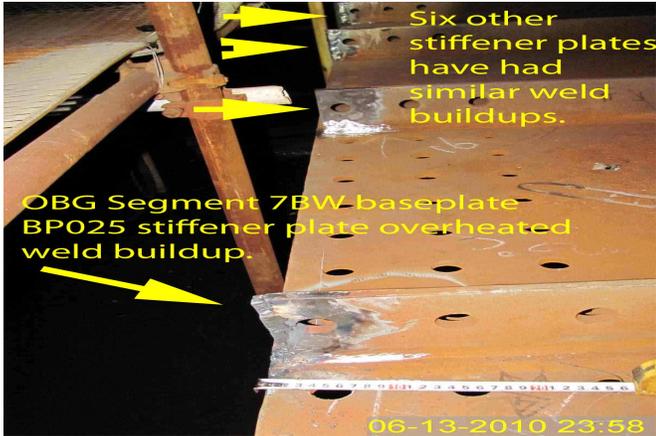
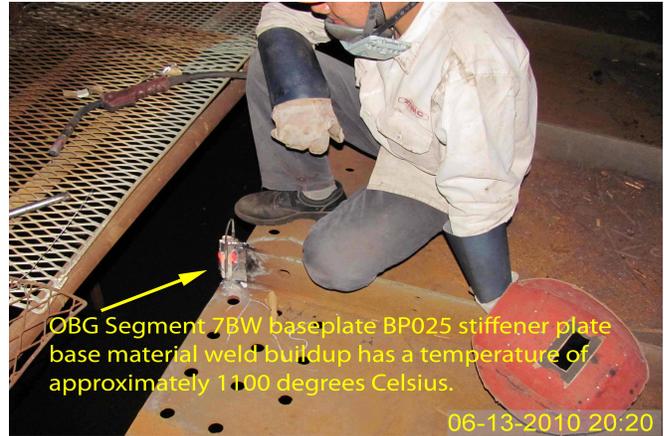
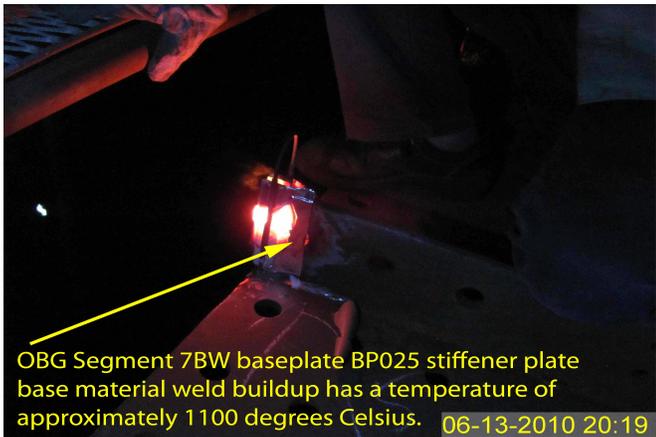
This QA Inspector observed ZPMC welder Mr. Zhou Pan, welder 220063 performing base material weld buildup of OBG segment 7BW bottom plate BP025 stiffener adjacent to weld BP025-050 , using flux cored welding procedure WPS-345-FCAW-3G(3F)-Repair-1, reference repair document B-WR13561. This repair document identified that bottom plate BP025, near panel point PP51 in the area where cross beam CB7 is to be attached has various stiffener plates that are too short. The repair document allows use of a single piece of ceramic backing on the end of the stiffener plate during the weld repairs and ZPMC has two ceramic backing plates, one on either side of the stiffener plate. Welder Mr. Zhou Pan appeared to be making multiple weld passes on the stiffener plate adjacent to weld BP025-050 without allowing the weld material to cool. This QA Inspector observed the weld material and adjacent base material to be bright red as a result of the welding heat input. This QA Inspector used an 1100 degree Celsius Tempilstik to determine the base material directly adjacent to the weld appears to have been heated to a temperature that exceeds 1100 degrees Celsius. The welding procedure states the maximum welding interpass temperature is 230 degrees Celsius. ZPMC CWI Inspectors Mr. Liu Hua Jie and Mr. Zhu Zhong Hai were informed that an incident report will be issued. ZPMC had the majority of the weld material on the end of this stiffener plate cut off with a torch. ZPMC intends to reweld this area at a later time. Several other stiffeners have also been welded in a similar manner. Items observed on this date do not appear to fully comply with applicable contract documents. See the photographs below for additional information.

This QA Inspector observed ZPMC welder Mr. Mao Li Wei, stencil 045213 is using shielded metal welding procedure WPS-345-SMAW-3G(3F)-Repair to make OBG stiffener plate weld repairs to weld SEG039-050 which was identified as having visual rejections. This weld is located on OBG segment 7DW between panel points PP57 and PP58 adjacent to where the crossbeam is to be attached. This QA Inspector observed Mr. Mao Li Wei has made 3F (vertical) and 4F (overhead) position welds. This QA Inspector observed Mr. Mao Li Wei appears to be certified to make welds in the 3F position and that he is not certified to make 4F position welds. This QA Inspector informed ZPMC CWI Inspectors Mr. Liu Hua Jie and Mr. Zhu Zhong Hai that Mr. Mao Li Wei has welded in the 4F (overhead) position and he does not appear to be certified to make that position weld. ZPMC CWI Inspector Mr. Liu Hua Jie informed this QA Inspector that this weld material will be ground off and the area will be MT inspected prior to having another welder make this weld repair. This QA Inspector observed ZPMC did appear to grind off the weld and an ABF MT Inspector performed MT inspections of the ground areas. Items observed on this date do not fully appear to comply with applicable contract documents.
