**DEPARTMENT OF TRANSPORTATION**

Contract #: 04-0120F4Cty: SF/ALA Rte: 80 PM: 13.2/13.9File #: 69.28**WELDING INSPECTION REPORT****Resident Engineer:** Pursell, Gary**Address:** 333 Burma Road**City:** Oakland, CA 94607**Report No:** WIR-014934**Date Inspected:** 10-Jun-2010**Project Name:** SAS Superstructure**OSM Arrival Time:** 700**Prime Contractor:** American Bridge/Fluor Enterprises, a JV**OSM Departure Time:** 1900**Contractor:** Zhenhua Port Machinery Company, Ltd (ZPMC), Changxing Island **Location:** Shanghai, China

## WELDING INSPECTION REPORT

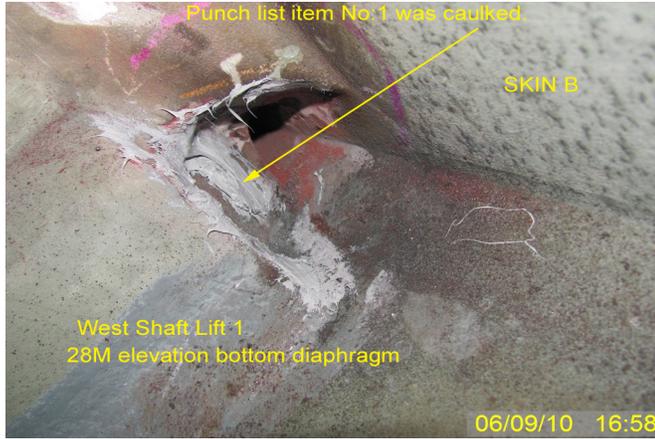
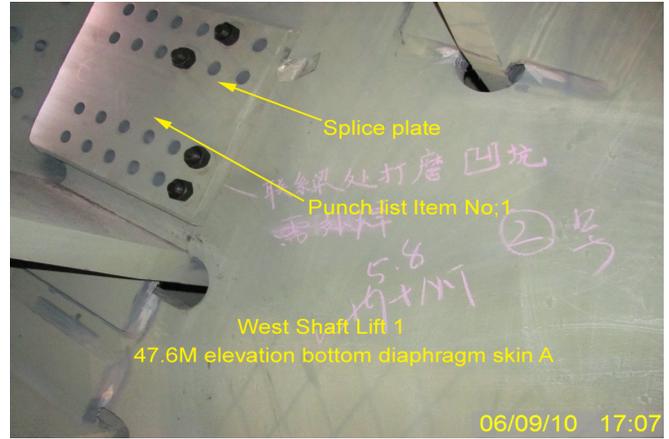
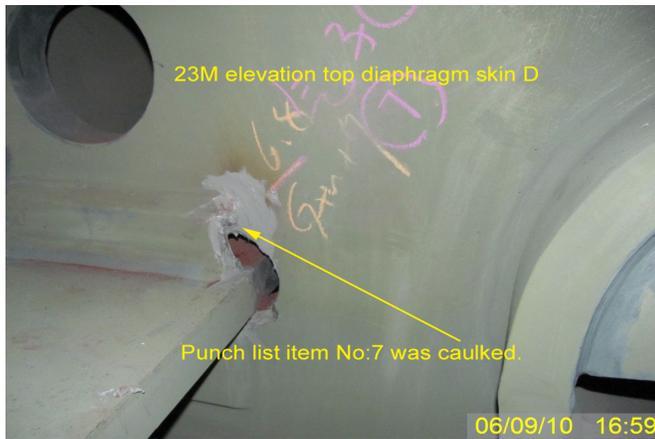
As per the NWIT # 005942 (OS2303) VT&MT performed Tower trail assembly area West Shaft Lift 1 (repair after painting) and discovered the following issues:

1. 47.6M elevation bottom diaphragm skin A item No:1 splice plate was installed.
2. 33M elevation item No:4 was not found.
3. 28M elevation bottom diaphragm skin B item No;1 was already caulked.
4. 23M elevation top diaphragm skin E item No; 8 was already caulked and Skin D item No:7 was already caulked.
5. 23M elevation bottom diaphragm skin D item No;4 was already caulked.

All other locations VT, MT 15% performed and found acceptable. It was informed to the lead Inspector for further action. For further information, please see the attached pictures.
