DEPARTMENT OF TRANSPORTATION

Contract #: 04-0120F4Cty: SF/ALA Rte: 80 PM: 13.2/13.9File #: 1.28**WELDING INSPECTION REPORT****Resident Engineer:** Pursell, Gary**Address:** 333 Burma Road**City:** Oakland, CA 94607**Report No:** WIR-014984**Date Inspected:** 17-Jun-2010**Project Name:** SAS Superstructure**OSM Arrival Time:** 1100**Prime Contractor:** American Bridge/Fluor Enterprises, a JV**OSM Departure Time:** 1930**Contractor:** American Bridge/Fluor Enterprises, a JV**Location:** Job Site**CWI Name:** See Below**CWI Present:** Yes No**Inspected CWI report:** Yes No N/A**Rod Oven in Use:** Yes No N/A**Electrode to specification:** Yes No N/A**Weld Procedures Followed:** Yes No N/A**Qualified Welders:** Yes No N/A**Verified Joint Fit-up:** Yes No N/A**Approved Drawings:** Yes No N/A**Approved WPS:** Yes No N/A**Delayed / Cancelled:** Yes No N/A**Bridge No:** 34-0006**Component:** Orthotropic Box Girders**Summary of Items Observed:**

WELDING INSPECTION REPORT

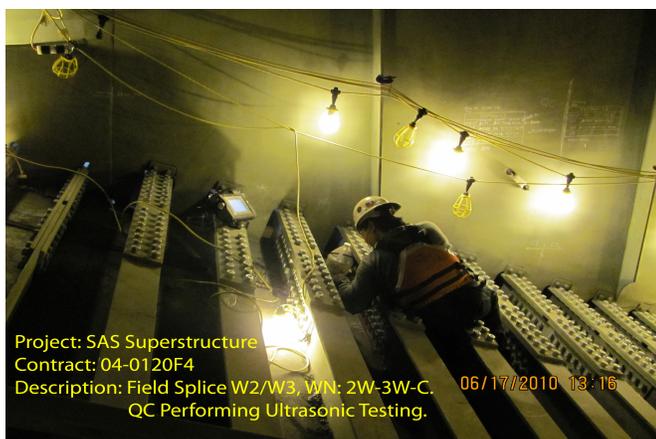
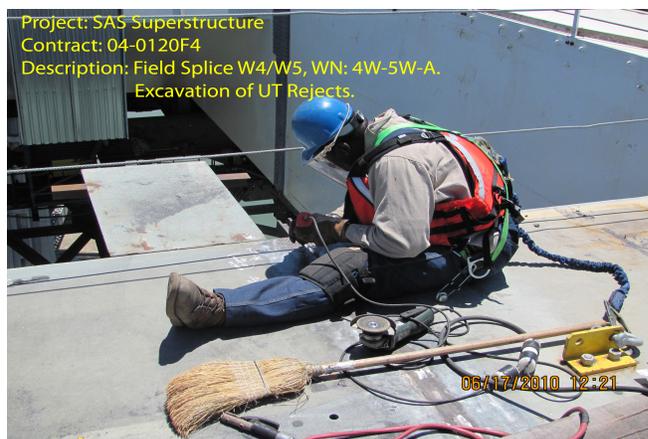
The digital photographs below illustrate the work observed during this scheduled shift.
