DEPARTMENT OF TRANSPORTATION

Contract #: 04-0120F4Cty: SF/ALA Rte: 80 PM: 13.2/13.9File #: 13.28**WELDING INSPECTION REPORT****Resident Engineer:** Pursell, Gary**Address:** 333 Burma Road**City:** Oakland, CA 94607**Report No:** WIR-015027**Date Inspected:** 18-Jun-2010**Project Name:** SAS Superstructure**OSM Arrival Time:** 1000**Prime Contractor:** American Bridge/Fluor Enterprises, a JV**OSM Departure Time:** 1830**Contractor:** Oregon Iron Works Clackamas, Or.**Location:** Clackamas, OR

CWI Name:	M. Gregson, J. Salazar, G. Mundt	CWI Present:	Yes	No			
Inspected CWI report:	Yes	No	N/A	Rod Oven in Use:	Yes	No	N/A
Electrode to specification:	Yes	No	N/A	Weld Procedures Followed:	Yes	No	N/A
Qualified Welders:	Yes	No	N/A	Verified Joint Fit-up:	Yes	No	N/A
Approved Drawings:	Yes	No	N/A	Approved WPS:	Yes	No	N/A
				Delayed / Cancelled:	Yes	No	N/A
Bridge No:	34-0006	Component:	Hinge K Pipe Beams

Hinge-K Pipe Beam Assembly 101A-3:

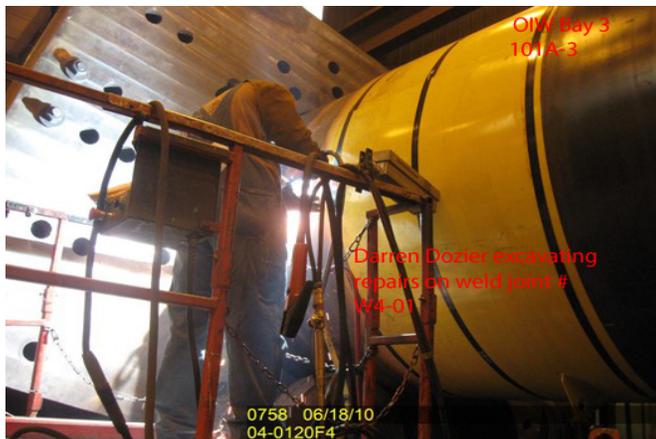
The QA Inspector observed Darren Dozier, performing backgouging on the weld joint, designated as # W4-01. The QA Inspector noted that this weld joint was the 120A-3 Fuse to 102A-3 Forging and designated as an AWS D1.5 B-U7-S, Complete Joint Penetration (CJP). The QA Inspector observed Mr. Dozier performing the backgouge in the vertical position, utilizing the Carbon Arc process and that pre-heat was intermittently applied, utilizing a previously set-up stationary torch or rosebud. The QA Inspector observed that the backgouge was being performed on the non-critical weld repair, which was previously ultrasonically tested and rejected by OIW QC Inspectors. The QA Inspector observed that Mr. Dozier was currently performing this backgouge on "indication #4", as recorded on OIW's Ultrasonic Examination Report (# 2244-10-UT-08) and that Mr. Shepherd was performing this, from the exterior of the weld joint. Mr. Dozier explained that at this time, no defect was visually discovered.

The QA Inspector observed that the backgouging continued throughout the entire shift. The QA Inspector was informed by Lead QC Inspector Mike Gregson that the backgouging will continue on swing shift and will possibly start the Flux Core Arc Welding (FCAW), on the repairs.
