DEPARTMENT OF TRANSPORTATION

Contract #: 04-0120F4Cty: SF/ALA Rte: 80 PM: 13.2/13.9File #: 1.28**WELDING INSPECTION REPORT****Resident Engineer:** Pursell, Gary**Address:** 333 Burma Road**City:** Oakland, CA 94607**Report No:** WIR-015028**Date Inspected:** 21-Jun-2010**Project Name:** SAS Superstructure**OSM Arrival Time:** 1100**Prime Contractor:** American Bridge/Fluor Enterprises, a JV**OSM Departure Time:** 1930**Contractor:** American Bridge/Fluor Enterprises, a JV**Location:** Job Site**CWI Name:** See Below**CWI Present:** Yes No**Inspected CWI report:** Yes No N/A**Rod Oven in Use:** Yes No N/A**Electrode to specification:** Yes No N/A**Weld Procedures Followed:** Yes No N/A**Qualified Welders:** Yes No N/A**Verified Joint Fit-up:** Yes No N/A**Approved Drawings:** Yes No N/A**Approved WPS:** Yes No N/A**Delayed / Cancelled:** Yes No N/A**Bridge No:** 34-0006**Component:** Orthotropic Box Girders**Summary of Items Observed:**

WELDING INSPECTION REPORT

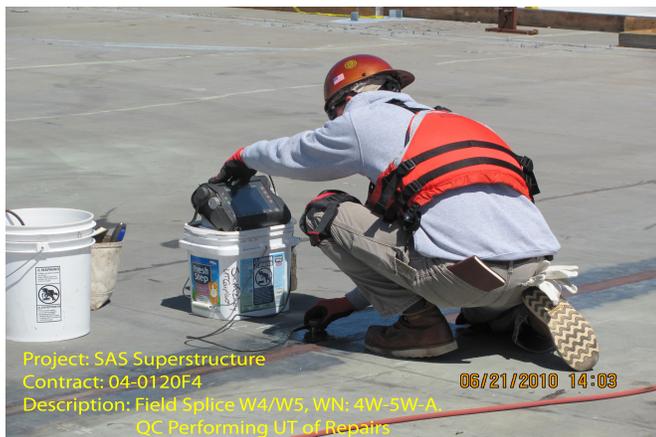
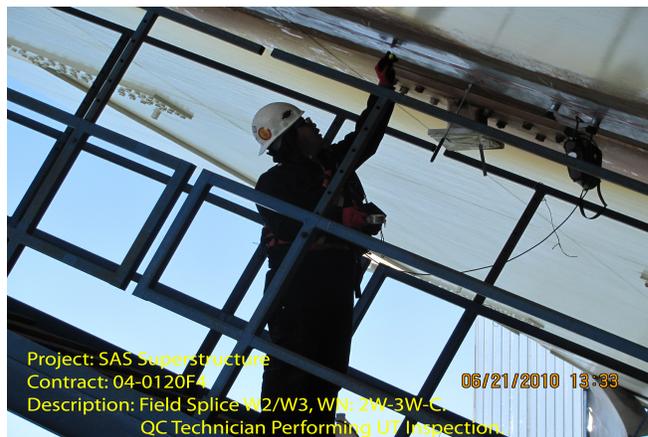
The digital photographs below illustrate the work observed during this scheduled shift.
