**DEPARTMENT OF TRANSPORTATION**

Contract #: 04-0120F4Cty: SF/ALA Rte: 80 PM: 13.2/13.9File #: 1.28**WELDING INSPECTION REPORT****Resident Engineer:** Pursell, Gary**Address:** 333 Burma Road**City:** Oakland, CA 94607**Report No:** WIR-015029**Date Inspected:** 21-Jun-2010**Project Name:** SAS Superstructure**OSM Arrival Time:** 1000**Prime Contractor:** American Bridge/Fluor Enterprises, a JV**OSM Departure Time:** 1830**Contractor:** American Bridge/Fluor Enterprises, a JV**Location:** Job Site

<b>CWI Name:</b>	Jim Cunningham and Bernie Docena			<b>CWI Present:</b>	<b>Yes</b>	<b>No</b>	
<b>Inspected CWI report:</b>	<b>Yes</b>	<b>No</b>	<b>N/A</b>	<b>Rod Oven in Use:</b>	<b>Yes</b>	<b>No</b>	<b>N/A</b>
<b>Electrode to specification:</b>	<b>Yes</b>	<b>No</b>	<b>N/A</b>	<b>Weld Procedures Followed:</b>	<b>Yes</b>	<b>No</b>	<b>N/A</b>
<b>Qualified Welders:</b>	<b>Yes</b>	<b>No</b>	<b>N/A</b>	<b>Verified Joint Fit-up:</b>	<b>Yes</b>	<b>No</b>	<b>N/A</b>
<b>Approved Drawings:</b>	<b>Yes</b>	<b>No</b>	<b>N/A</b>	<b>Approved WPS:</b>	<b>Yes</b>	<b>No</b>	<b>N/A</b>
				<b>Delayed / Cancelled:</b>	<b>Yes</b>	<b>No</b>	<b>N/A</b>
<b>Bridge No:</b>	34-0006			<b>Component:</b>	Orthotropic

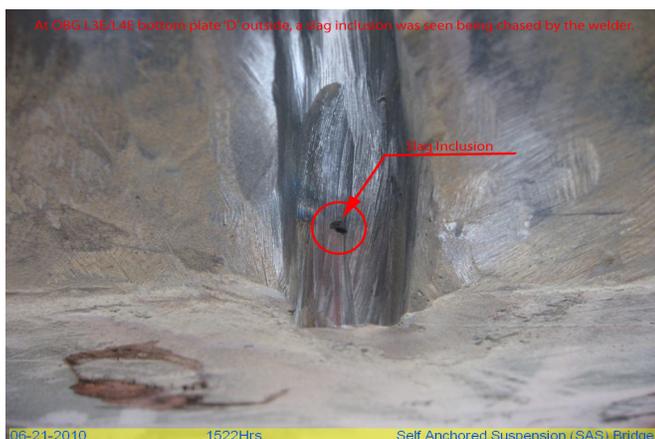
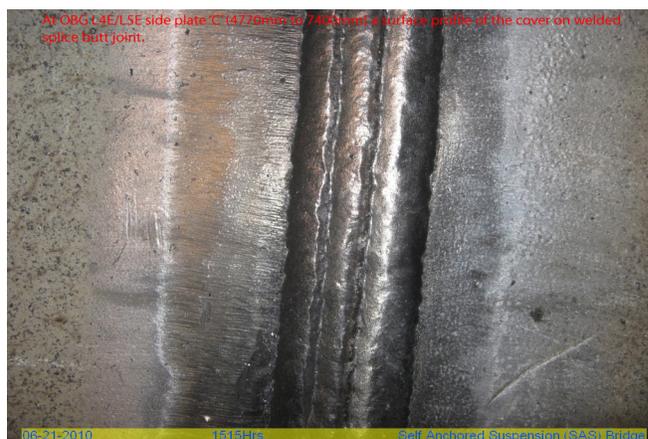
(overhead) position utilizing a Shielded Metal Arc Welding (SMAW) with 1/8" diameter E7018H4R electrode. The welder was noted using the SMAW on an excavated area that was having weld defect instead of the previous FCAW-G process. The joint being welded has the backing bar gouged using the Esab Plasma Arc machine and was ground smooth. The splice joint was preheated to greater than 150 degree Fahrenheit prior welding and the vicinity was properly protected from wind and other weather conditions. During welding, ABF Quality Control (QC) Jim Cunningham was noted monitoring the welder and his welding parameters.

At OBG L4E/L5E bottom plate 'D' outside, ABF welder Howell Bryce was observed perform alternately back gouging and grinding on the splice butt joint backing bar removal of 'D' plate. The welder was using Esab plasma arc gouging machine mounted to a track. During the shift, gouging and grinding of the backing bar and some of the base metal were not completed and should continue tomorrow.
