Contract #: 04-0120F4Cty: SF/ALA Rte: 80 PM: 13.2/13.9File #: 13.28**WELDING INSPECTION REPORT****Resident Engineer:** Pursell, Gary**Address:** 333 Burma Road**City:** Oakland, CA 94607**Report No:** WIR-015042**Date Inspected:** 21-Jun-2010**Project Name:** SAS Superstructure**OSM Arrival Time:** 1000**Prime Contractor:** American Bridge/Fluor Enterprises, a JV**OSM Departure Time:** 1830**Contractor:** Oregon Iron Works Clackamas, Or.**Location:** Clackamas, OR

CWI Name:	M. Gregson, J. Salazar, G. Mundt	CWI Present:	Yes	No			
Inspected CWI report:	Yes	No	N/A	Rod Oven in Use:	Yes	No	N/A
Electrode to specification:	Yes	No	N/A	Weld Procedures Followed:	Yes	No	N/A
Qualified Welders:	Yes	No	N/A	Verified Joint Fit-up:	Yes	No	N/A
Approved Drawings:	Yes	No	N/A	Approved WPS:	Yes	No	N/A
				Delayed / Cancelled:	Yes	No	N/A
Bridge No:	34-0006	Component:	Hinge K Pipe Beams

Hinge-K Pipe Beam Assembly 101A-3:

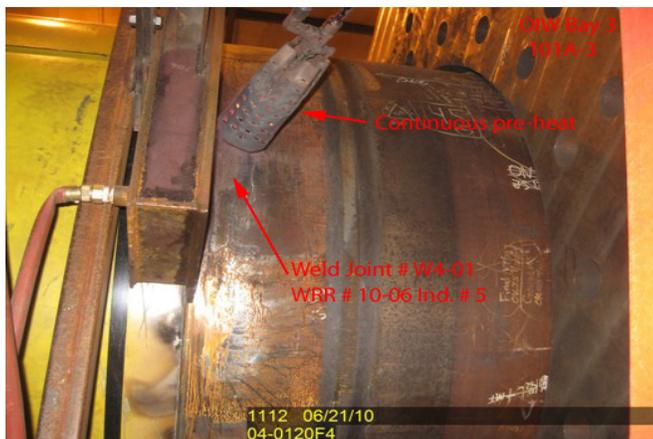
The QA Inspector observed swing shift WID #S74 (Bounheune Savanh) performing additional backgouging, utilizing the Carbon Arc process on the above mentioned weld joint. The QA Inspector observed that the backgouging was being performed on the non-critical weld repair plotted as Indication # 3, per the applicable WRR # 10-06. The QA Inspector observed that OIW QC Inspector Gary Mundt was present on this swing shift and Mr. Mundt explained that OIW production had decided to perform this additional backgouging, due to not visually discovering the defect in the weld on the initial backgouge.

The QA Inspector later observed that the backgouging had been completed and WID # S74 was performing Flux Core Arc welding (FCAW) on the repair, in the vertical position. QC Inspector Mundt explained that he had performed Visual and Magnetic particle testing on the excavation and found no rejectable indications. QC Inspector Mundt explained that the backgouge area was measured and did not exceed 65 % of the weld thickness, which would require a Critical Weld Repair.

QC Inspector Mundt then explained that Welding Procedure Specification (WPS) 3048 was being utilized for the repair and that prior to the FCAW being started, pre-heat was verified to be approximately 400 degrees Fahrenheit and travel speed of 9 inches per minute (229 mm/minute). QC Inspector Mundt explained that in-process welding parameters were recorded at 230 amps and 25 volts, during the in-process FCAW and the QA Inspector verified these parameters.
