DEPARTMENT OF TRANSPORTATION

Quality Assurance and Source Inspection

Contract #: 04-0120F4Cty: SF/ALA Rte: 80 PM: 13.2/13.9File #: 69.28**WELDING INSPECTION REPORT****Resident Engineer:** Pursell, Gary**Address:** 333 Burma Road**City:** Oakland, CA 94607**Report No:** WIR-015068**Date Inspected:** 24-May-2010**Project Name:** SAS Superstructure**OSM Arrival Time:** 700**Prime Contractor:** American Bridge/Fluor Enterprises, a JV**OSM Departure Time:** 1900**Contractor:** Zhenhua Port Machinery Company, Ltd (ZPMC), Changxing Island **Location:** Shanghai, China**CWI Name:** Li Yang**CWI Present:** Yes No**Inspected CWI report:** Yes No N/A**Rod Oven in Use:** Yes No N/A**Electrode to specification:** Yes No N/A**Weld Procedures Followed:** Yes No N/A**Qualified Welders:** Yes No N/A**Verified Joint Fit-up:** Yes No N/A**Approved Drawings:** Yes No N/A**Approved WPS:** Yes No N/A**Delayed / Cancelled:** Yes No N/A**Bridge No:** 34-0006**Component:** OBG Segment**Summary of Items Observed:**

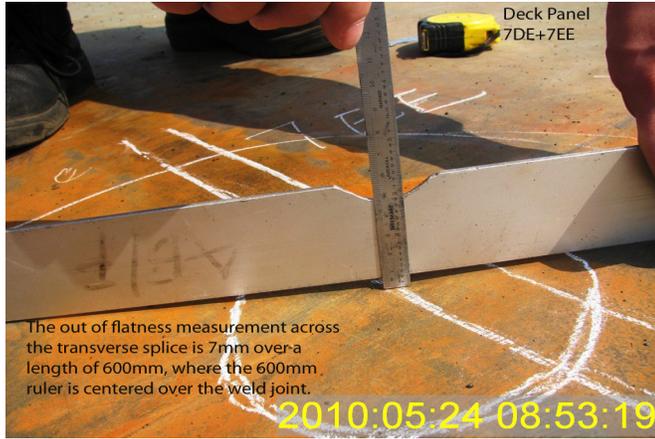
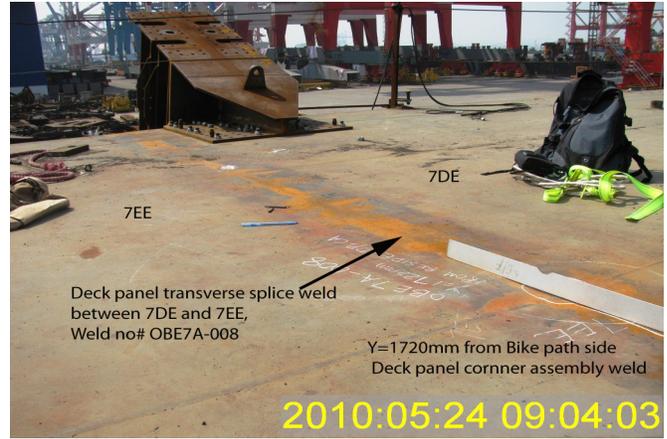
This QA inspector observed in Deck panel for skin flatness at the 7DE to 7EE segment transverse splice weld joint.

The surface flatness survey data was taken on the exterior side (flat side of the weld) of the Deck panel. The out of flatness measurement across the transverse splice is 7mm over a length of 600mm, where the 600mm ruler is centered over the weld joint.

The Transverse weld splice is identified as: OBE7A-008

The location was at the Deck panel of Segment 7DE and 7EE.

Y= 1720 mm from Deck panel Corner assembly weld (Bike path side)

The incident report is issued for the above mentioned discrepancy observed in 7DE to 7EE transverse splice weld joint. And prior to issue it was informed to ZPMC QC and ABF QA.
