Contract #: 04-0120F4Cty: SF/ALA Rte: 80 PM: 13.2/13.9File #: 69.28**WELDING INSPECTION REPORT****Resident Engineer:** Pursell, Gary**Address:** 333 Burma Road**City:** Oakland, CA 94607**Report No:** WIR-015071**Date Inspected:** 15-Jun-2010**Project Name:** SAS Superstructure**OSM Arrival Time:** 700**Prime Contractor:** American Bridge/Fluor Enterprises, a JV**OSM Departure Time:** 1900**Contractor:** Zhenhua Port Machinery Company, Ltd (ZPMC), Changxing Island **Location:** Shanghai, China**CWI Name:****CWI Present:**

Bridge No: 34-0006**Component:** OBG Trial Assembly**Summary of Items Observed:**

Orthotropic Box Girder (OBG) Trial Assembly Areas

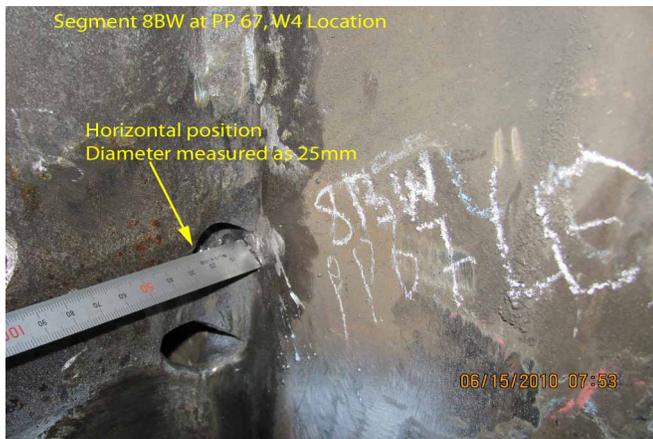
Segment 8BW (Cope Hole)

This Quality Assurance (QA) Inspector measured and recorded the Cope Hole diameter and smoothness for the Floor Beam Stiffener to the Longitudinal Diaphragm (LD) Flange at PP 67 East side at Cross Beam side at Work Point (W4).

The measured readings was recorded on Dimension Control Form and was submitted to the Lead and Engineer for review. Please refer the picture attached below for more comprehensive details.
