Contract #: 04-0120F4Cty: SF/ALA Rte: 80 PM: 13.2/13.9File #: 1.28**WELDING INSPECTION REPORT****Resident Engineer:** Pursell, Gary**Address:** 333 Burma Road**City:** Oakland, CA 94607**Report No:** WIR-015174**Date Inspected:** 28-Jun-2010**Project Name:** SAS Superstructure**OSM Arrival Time:** 1100**Prime Contractor:** American Bridge/Fluor Enterprises, a JV**OSM Departure Time:** 1930**Contractor:** American Bridge/Fluor Enterprises, a JV**Location:** Job Site**CWI Name:** See Below**CWI Present:** Yes No**Inspected CWI report:** Yes No N/A**Rod Oven in Use:** Yes No N/A**Electrode to specification:** Yes No N/A**Weld Procedures Followed:** Yes No N/A**Qualified Welders:** Yes No N/A**Verified Joint Fit-up:** Yes No N/A**Approved Drawings:** Yes No N/A**Approved WPS:** Yes No N/A**Delayed / Cancelled:** Yes No N/A**Bridge No:** 34-0006**Component:** Orthotropic Box Girders**Summary of Items Observed:**

WELDING INSPECTION REPORT

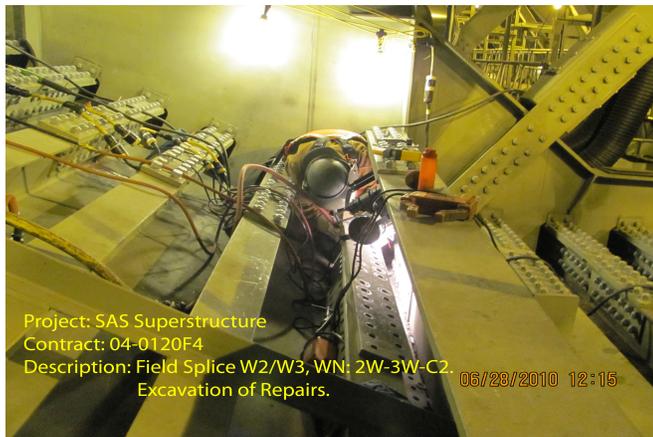
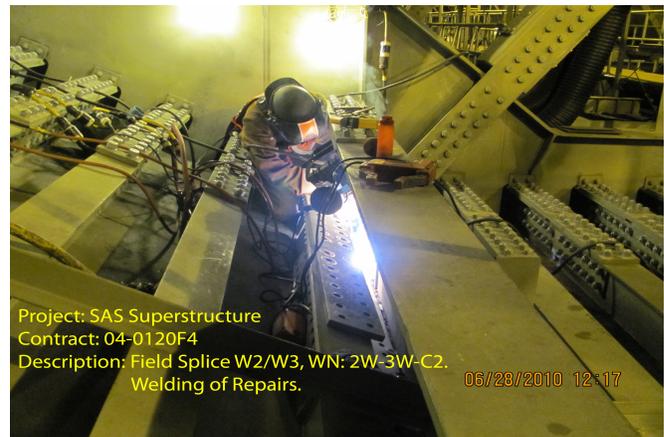
The QAI observed the welder James Zhen ID-6001 perform the excavations and repair welding of the areas marked as UT rejects on the Complete Joint Penetration (CJP) groove welds identified as WN: 2W-3W-C2. Also, at the conclusion of the excavations the QC technician Tom Pasqualone performed a Magnetic Particle Test (MPT) of the excavated areas and no rejectable indications were noted. The application and evaluation of the MPT appeared to comply with the MPT procedure identified as SE-MT-CT-D1.5-101 Rev. 4. The repair welding was performed utilizing the Shielded Metal Arc Welding (SMAW) process and 3.2mm electrode as per the Welding Procedure Specification (WPS) identified as ABF-WPS-D15-1000 Repair Rev. 2. The WPS was also used by the QC inspector, Mr. Pasqualone, as a reference to monitor and verify the Direct Current welding parameters and were noted as 126 amps. The work was placed in an approximately vertical plane with groove positioned approximately at an 22 degree incline and the weld progression up.

The QAI also observed the Ultrasonic Testing (UT) of the bottom plate field splice identified as WN: 3W-4E-D1. The testing was performed by the QC technician Jesse Cayabyab utilizing a G.E./Krautkramer USM 35X. Mr. Cayabyab also utilized the UT Procedure identified as SE-UT-D1.5-CT-100 Rev.4 during the examination of the CJP. The QC technician performed the required longitudinal wave utilizing a 1" diameter transducer for base metal soundness and a .63 x .75 rectangular transducer to perform the shear wave testing during the testing for weld soundness. At the conclusion of this shift the QAI observed that the QC technician noted two (2) rejectable flaws which were marked on the A-face of the groove weld. The UT examination was not completed during this shift.

The digital photographs below illustrate the work observed during this scheduled shift.
