DEPARTMENT OF TRANSPORTATION

Quality Assurance and Source Inspection

Contract #: 04-0120F4Cty: SF/ALA Rte: 80 PM: 13.2/13.9File #: 1.28**WELDING INSPECTION REPORT****Resident Engineer:** Pursell, Gary**Address:** 333 Burma Road**City:** Oakland, CA 94607**Report No:** WIR-015255**Date Inspected:** 01-Jul-2010**Project Name:** SAS Superstructure**OSM Arrival Time:** 1100**Prime Contractor:** American Bridge/Fluor Enterprises, a JV**OSM Departure Time:** 1930**Contractor:** American Bridge/Fluor Enterprises, a JV**Location:** Job Site**CWI Name:** See Below**CWI Present:** Yes No**Inspected CWI report:** Yes No N/A**Rod Oven in Use:** Yes No N/A**Electrode to specification:** Yes No N/A**Weld Procedures Followed:** Yes No N/A**Qualified Welders:** Yes No N/A**Verified Joint Fit-up:** Yes No N/A**Approved Drawings:** Yes No N/A**Approved WPS:** Yes No N/A**Delayed / Cancelled:** Yes No N/A**Bridge No:** 34-0006**Component:** Orthotropic Box Girders**Summary of Items Observed:**

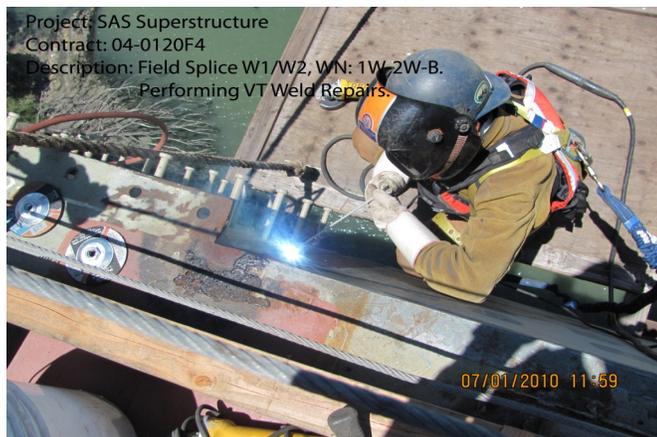
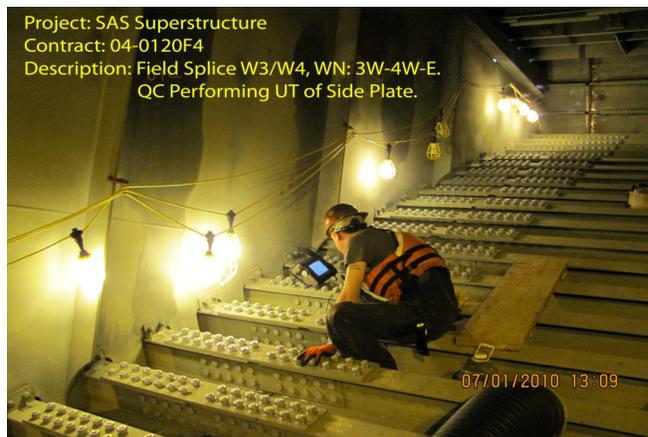
The digital photographs below illustrate the work observed during this scheduled shift.
