DEPARTMENT OF TRANSPORTATION

Contract #: 04-0120F4Cty: SF/ALA Rte: 80 PM: 13.2/13.9File #: 69.28**WELDING INSPECTION REPORT****Resident Engineer:** Pursell, Gary**Address:** 333 Burma Road**City:** Oakland, CA 94607**Report No:** WIR-015434**Date Inspected:** 28-Jun-2010**Project Name:** SAS Superstructure**OSM Arrival Time:** 700**Prime Contractor:** American Bridge/Fluor Enterprises, a JV**OSM Departure Time:** 1900**Contractor:** Zhenhua Port Machinery Company, Ltd (ZPMC), Changxing Island **Location:** Shanghai, China**CWI Name:** Chen Shi Gang**CWI Present:** Yes No**Inspected CWI report:** Yes No N/A**Rod Oven in Use:** Yes No N/A**Electrode to specification:** Yes No N/A**Weld Procedures Followed:** Yes No N/A**Qualified Welders:** Yes No N/A**Verified Joint Fit-up:** Yes No N/A**Approved Drawings:** Yes No N/A**Approved WPS:** Yes No N/A**Delayed / Cancelled:** Yes No N/A**Bridge No:** 34-0006**Component:** OBG**Summary of Items Observed:**

BAY 04, DECK PANEL REPAIR

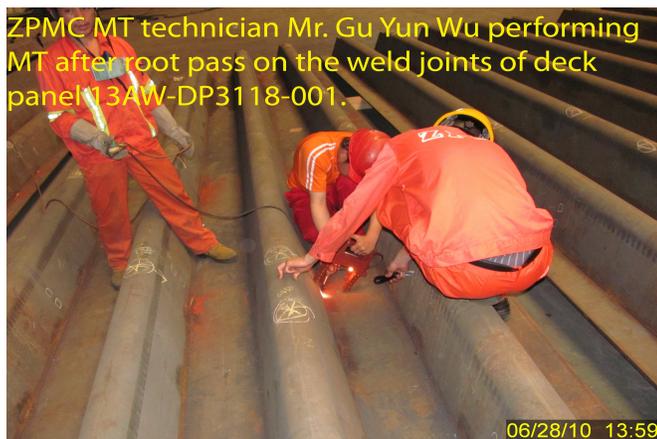
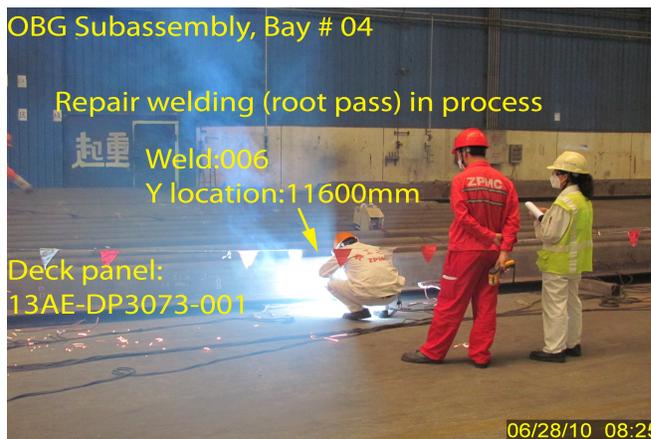
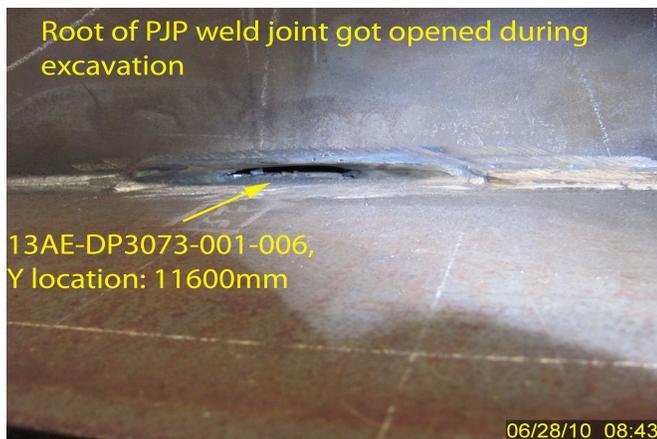
During random in process inspection this QA inspector observed that ZPMC personnel were performing excavation on PAUT repair locations. ZPMC QC is identified as Mr. Zhang Qian. The repair excavation details are as follows.

During random in process inspection this QA inspector observed that ZPMC personnel were performing repair welding (root pass) on the Partial Joint Penetration (PJP) weld joints of deck panel 13AE-DP3073-001. Welder is identified as 069469. ZPMC QC is identified as Mr. Zhang Qiao. The welding variables recorded by QC appeared to comply with WPS-345-FCAW-2G(2F)-FCM-Repair. The repair area details are as follows.

During random in process inspection this QA inspector observed that ZPMC personnel were performing repair welding (root pass) on the Partial Joint Penetration (PJP) weld joints of deck panel 13AW-DP3119-001. Welder is identified as 067250. ZPMC QC is identified as Mr. Zhang Qiao. The welding variables recorded by QC appeared to comply with WPS-345-FCAW-2G(2F)-FCM-Repair. The repair area details are as follows.

This QA inspector witnessed Magnetic Particle Testing (MT) performed by ZPMC MT technician Mr. Gu Yun Wu after root pass on the repair locations of weld joint of above mentioned deck panel. The repair area details are as follows.

During excavation of the repair location of 13AE-DP3073-001, weld joint: 006, Y location: 11600; the root got

opened. ZPMC could not provide the appropriate WPS for the open root repair area. So ZPMC did not proceed for further repair works.
