DEPARTMENT OF TRANSPORTATION

Quality Assurance and Source Inspection

Contract #: 04-0120F4Cty: SF/ALA Rte: 80 PM: 13.2/13.9File #: 69.28**WELDING INSPECTION REPORT****Resident Engineer:** Pursell, Gary**Address:** 333 Burma Road**City:** Oakland, CA 94607**Report No:** WIR-015436**Date Inspected:** 24-May-2010**Project Name:** SAS Superstructure**OSM Arrival Time:** 700**Prime Contractor:** American Bridge/Fluor Enterprises, a JV**OSM Departure Time:** 1900**Contractor:** Zhenhua Port Machinery Company, Ltd (ZPMC), Changxing Island **Location:** Shanghai, China

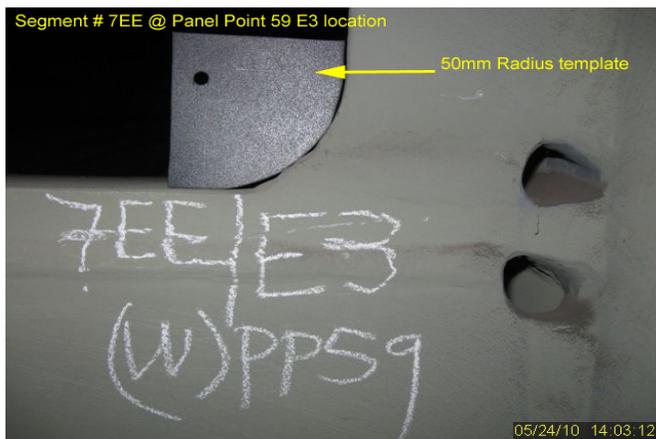
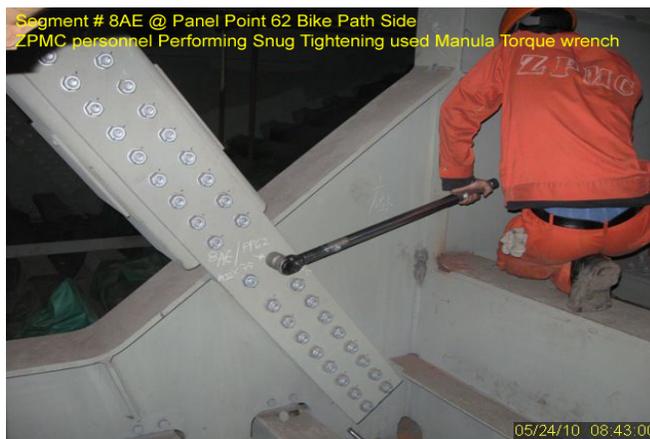
The QA inspector performed inspection for the Floor Beam Flange welded at Longitudinal Diaphragm for the Radius and Distance from the Flange to the Weld termination at E3 Location from Panel Point (PP) 48 to PP 61.5, East and West side of Floor Beam.

Report forwarded to team leader for further action, kindly refer to the pictures attached below when measured with 25mm Radius template and 50mm Radius template.
